City of Toledo

LINCOLN COUNTY, OREGON

Inflow and Infiltration Study

May 2011

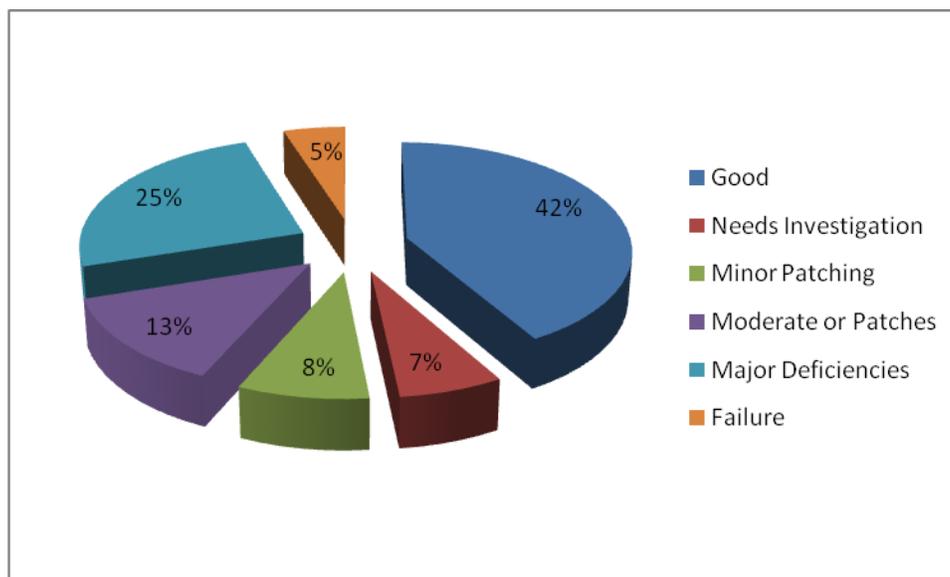
Figure 5.2 Televising Results

- 25 Segments are in average or better condition without any need for further work.
- 4 Segments need further investigation
- 5 Segments are in need of minor repairs that may be spot repairs
- 8 Segments require more major repairs or replacement but are not causing large problems yet
- 15 Segments have major damage throughout the pipe and should be repaired soon
- 3 Segments are near imminent failure

Overall, PVC and clay tile pipes are in good condition while the concrete pipe is typically either failing, near failure, or the pipe appears old and worn. Where liners are installed in the pipes, the liners are in good condition and providing good service. Short pipe patches are also performing well, though it can be observed that the pipe adjacent to them is now deteriorating and that they are a short term solution.
