Structural Evaluation for the Toledo Swimming Pool

Prepared for:
City of Toledo
&
Young Design Studio

October, 2014

Subject: Structural Evaluation

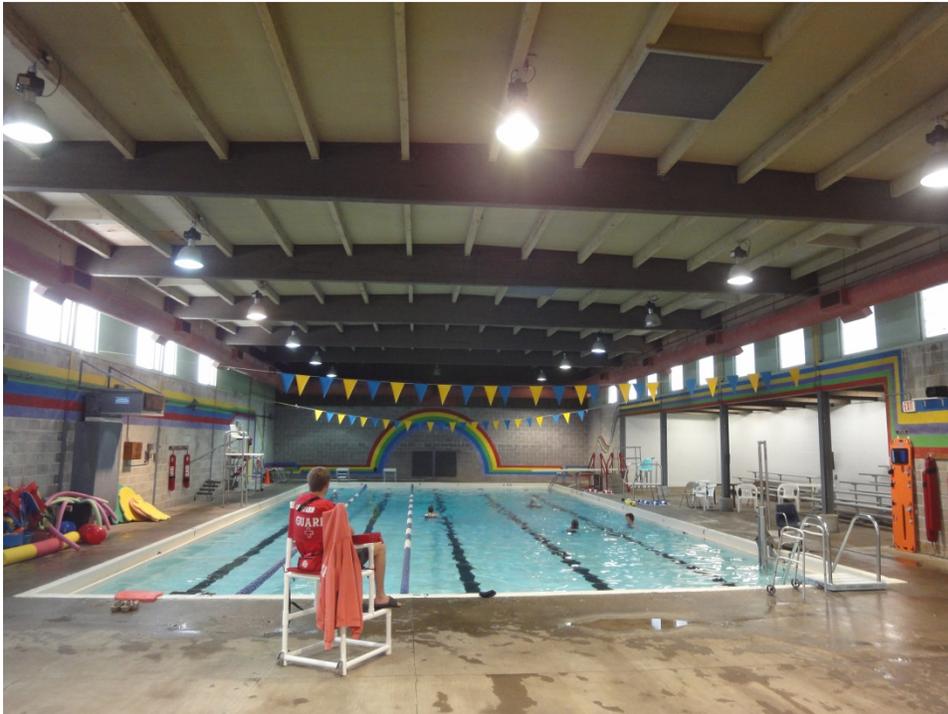
- Main Pool Building roof beams are 50% overstressed during current code loading conditions (Figure 2)

Figure 2 – Main Pool Building Interior - Facing North

- Reinforce glulam roof beams in-place
- Repair deteriorated wide-flange posts
- Install connections between wide-flange posts and CMU infill walls
- Remove and replace CMU shear walls (one bay each corner, each way)
- Remove and replace CMU along north wall and reinforce foundation
- Remove and replace roofing and insulation material
- Remove and replace perimeter roof sheathing
- Block all roof sheathing edges between roof purlins
- Re-nail roof sheathing to roof framing and blocking
- Installation of new equipment supports (evaluation of MEP components not included in the scope of this evaluation)

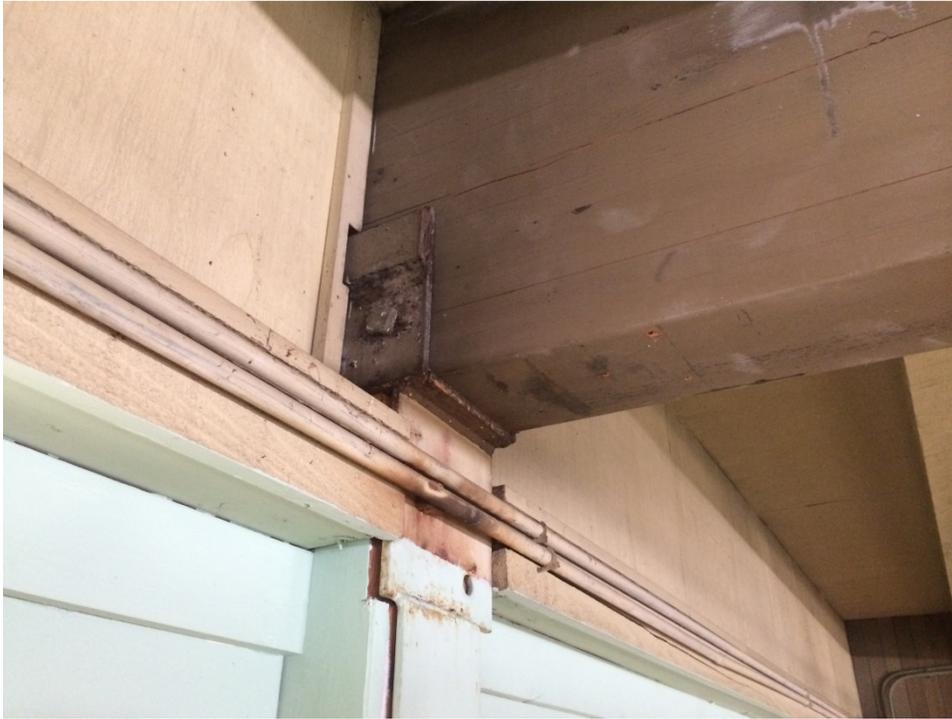
Figure 3 – Main Pool Building Roof Beam-Post Connection

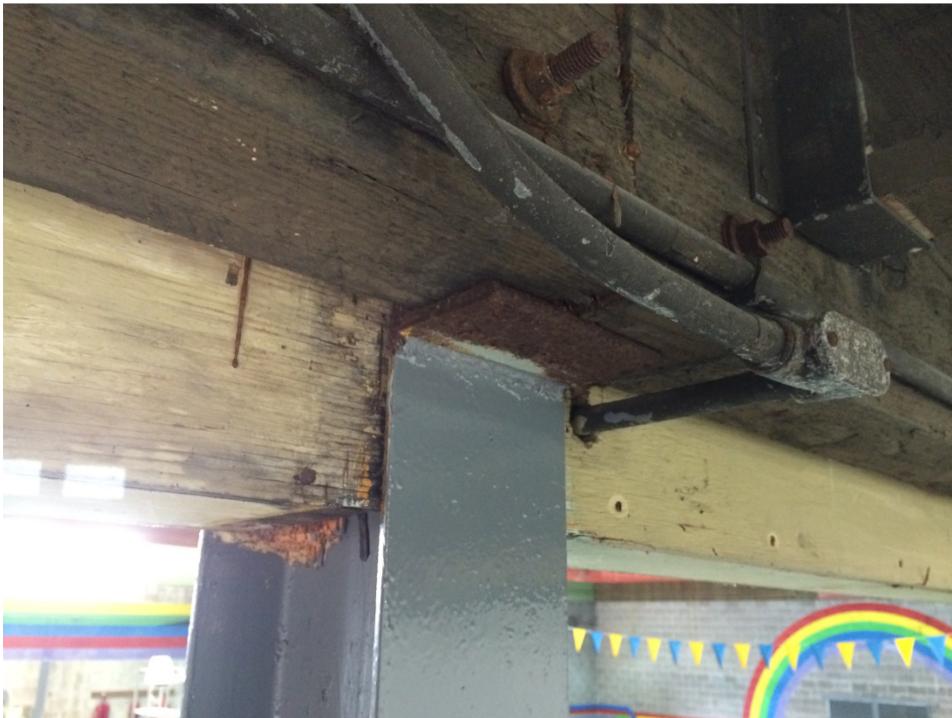
- Potential deterioration of roof sheathing (based on deterioration of main building roof sheathing)
- Insufficient connection between roof diaphragm and CMU shear walls
- Deterioration of structural wood framing at main pool building roof connection (Figure 4)

Figure 4 – Observation Area Structure Connection to Main Pool Building

- Remove and replace roofing and insulation material
- Replace deteriorated roof sheathing
- Install connections at 4' on-center between roof diaphragm and top of CMU walls on all three sides of observation area structure
- Remove and replace deteriorated wood beams at marriage line to main pool building

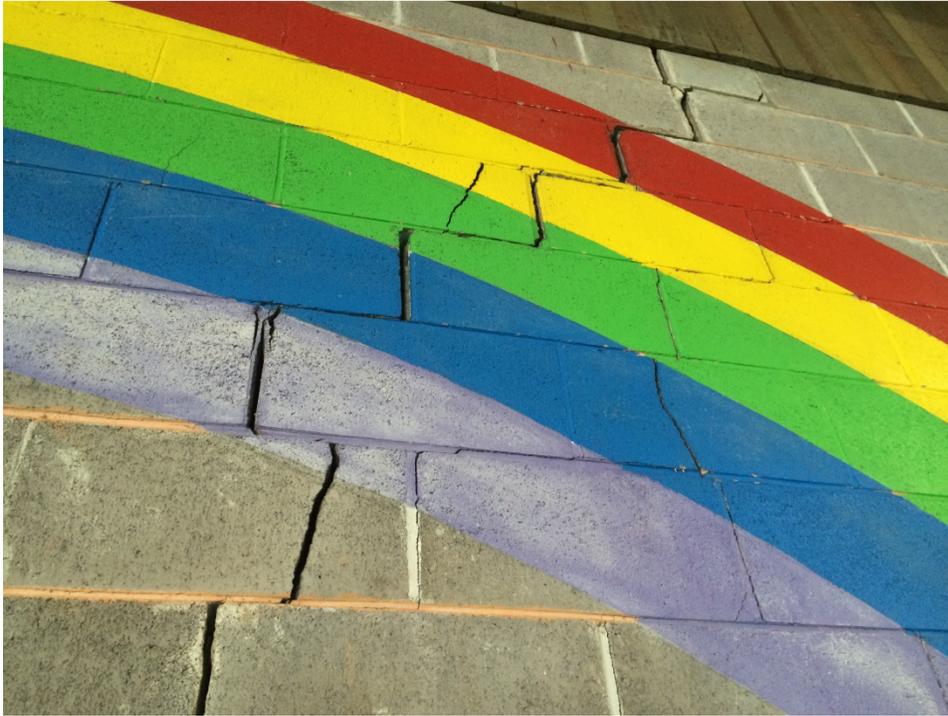
Cracking in the north wall is the only significant masonry damage in the facility. This section of wall was constructed prior to the 1973 sidewall infill work that was done when the bathhouse was rebuilt. The damage is concentrated at the return air louver opening that was installed at the same time. Drill investigation revealed a grouted cell at 48 inches on-center and the possible presence of bed joint reinforcing at 32 inches on-center. Window sill trim, and jamb trim destructive investigation revealed no significant deterioration. The cracks appear to be caused by minor differential settlement of the subgrade and lack of wall reinforcement. Geotechnical investigation was not within the scope of this assignment. Exterior pedestrian walk-around reveled no evidence of subsidence or other foundation related issues along remaining walls.

- Insufficient connection between wide-flange posts and CMU infill walls to ensure elements act as a single unit during lateral force application, also allowing the walls to fall away or into the facility
- Cracking of existing CMU wall at north end due to lack of reinforcement steel and suspect subgrade (Figure 5)

Figure 5 – Cracking of CMU North End Wall

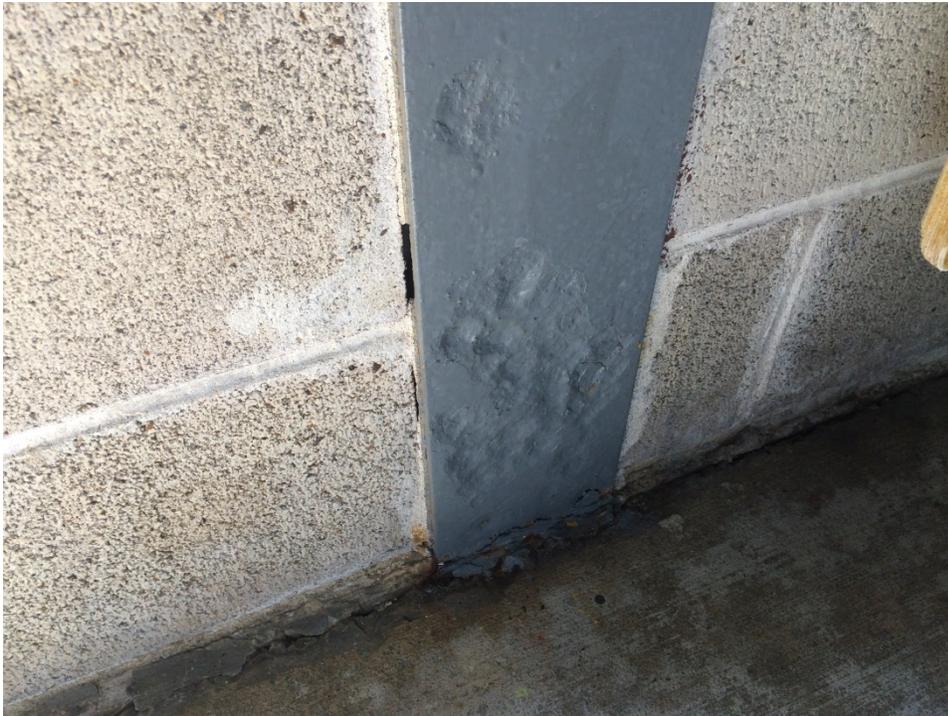
Steel sidewall columns are corroded from chlorine exposure at their bases inside the building. The corrosion to the exterior flange of the columns does not appear as extensive. There were visible signs of corrosion, but the exterior was not as degraded as the interior flanges. Columns at the observation area marriage line have been jacketed with concrete piers 16 inches up from the pool deck since our last inspection 2 years ago. It is possible that the steel columns are replacements for original timber columns. This idea is based on the discovery of brackets at the top of the stub column that rests on top of the CMU near the southeast corner of the main pool building. The masonry that supports it was constructed prior to the 1973 remodel. Rather than remove masonry for a new full height column, they elected to use a stub column on top.

Figure 6 – Deterioration of Steel Post Bases

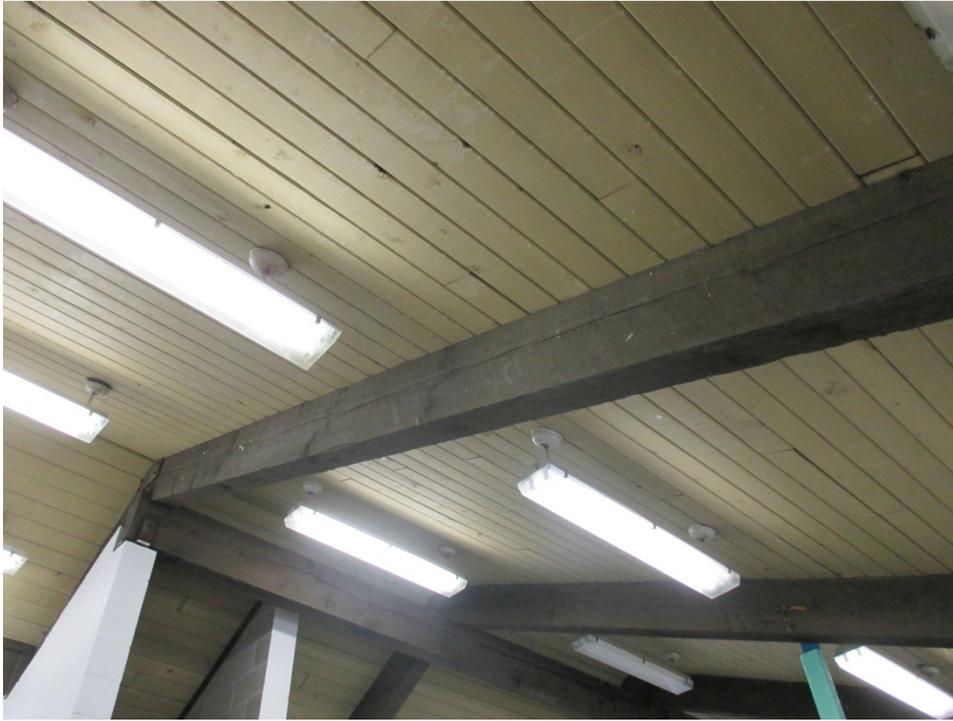
- Roof diaphragm shear capacity inadequate due to straight sheathing (Figure 7)
- Insufficient connection between roof and main pool building south wall to resist pounding action between structures

Figure 7 – Bathhouse Building Roof Beams and Decking

- Remove and replace roofing and insulation
- Install plywood roof sheathing over existing straight sheathing
- Install connection at 4' on-center between bathhouse roof diaphragm and new full height main pool building CMU walls

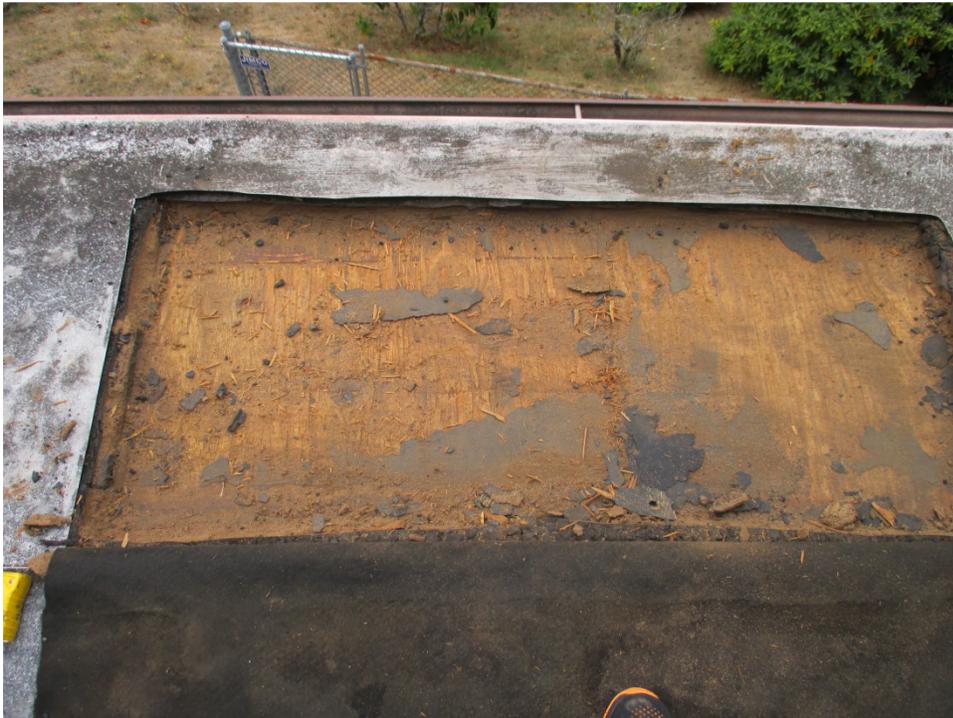
Near the south-west corner of the main pool building roof, the roofing itself was exactly the same and also wet to the touch when the single-ply was opened. When peeling the insulation out, it was wet and fell apart as it was pulled out unlike the insulation at the center of the roof. When peeling the bottom vapor barrier off it, easily took the top lamination of the plywood with it. The plywood at this location was visibly dry rotting and soft to the touch. The dry rot seems to stop at the first purlin from the edge.

- Perimeter CMU walls do not provide adequate shear capacity
- Roof diaphragm shear capacity inadequate to transfer lateral loads to end walls in transverse direction
- Deterioration of roof sheathing at roof diaphragm perimeter (Figure 8)
- Deterioration of wide-flange post bases at ground-line inside the building (Figure 6)
- Lack of connection between roof diaphragm and CMU infill walls (shear walls). Currently separated by weak wood wall framing with transom windows

Figure 8 – Deterioration of Main Pool Building Roof Sheathing
