# City of Toledo Oregon FIELD REPORT

July 14, 2011

**Underwater Cleaning and Inspection  
Ammon Road Tank  
1,000,000 Gallon  
Potable Water Storage Tank**

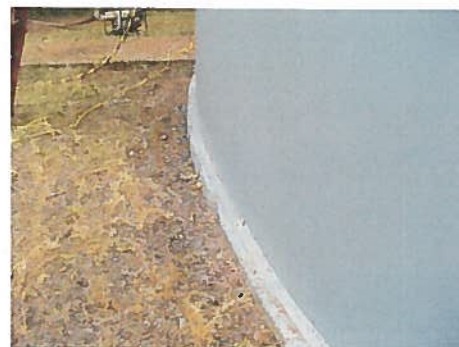
Exterior shell was found to be in excellent condition with no discrepancies noted. The coating being recently new exhibited excellent adhesion. No problematic concerns or blemishes were found on the shell.

The exterior ladder and upper hand rails appeared to be mechanically sound and were found to be useful. Weld joints and penetrations were free of surface rust and corrosion. The man way entry had a good gasket in place that had no cracking or weathering noted, no leaking was present and the coating once again was in excellent condition.

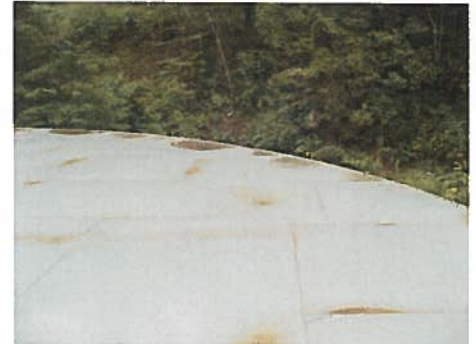
Exterior roof exhibited good coating adhesion overall. The only problematic areas of the exterior roof are the outer edges, as seen in the photo there are low spots that the water collects on. These areas where the water is standing has deteriorated the coating and surface corrosion is present. The roof top man way hatch was secured and exhibiting good coating adhesion, no weather stripping was present. The roof vent was in excellent shape with no concerns noted. The vent had a good secured screen in place.

2. The exterior roof coating around the outer edges has corrosion present where the water collects and has damaged the coating. These areas will need to be touched up regularly as the tank only has one support column in the middle and the outer edges are sunk in a little.
3. The interior coating is near the end of its useful service life and will need to be replaced in the near future. Many areas have failed and rust nodules have begun indicating pitting of the steel plates has started. Also found were large pieces of metal coming from the interior roof, these pieces of metal have landed on the coating and in some cases have damaged the coating.

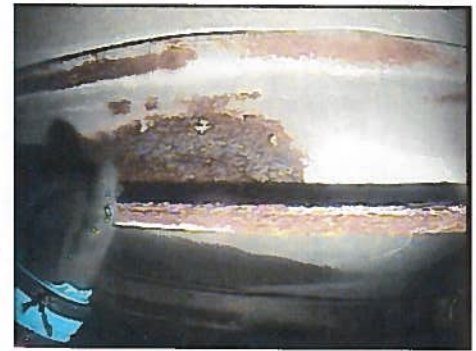
Observable roof plates, trusses, truss to wall gussets, center roof support plate and all associated welds and hardware are covered in corrosion. During the cleaning of the entire floor large rust particles were removed that are coming down from the roof. The edges of the trusses and the fillet welds of the roof plates are heavily corroded and are losing structural integrity. The coating is at the end of its service life and needs to be replaced. A few of the trusses have lost quite a bit of steel due to the corrosion. Before a new coating is put in place they need to be evaluated by a structural engineer as to determine how much loss they have had; a few of them may need to be replaced.

Based on the results of this underwater inspection and cleaning which took place, this tank needs to be taken out of service the interior roof needs to be evaluated by a structural engineer and the interior coating replaced in the near future.

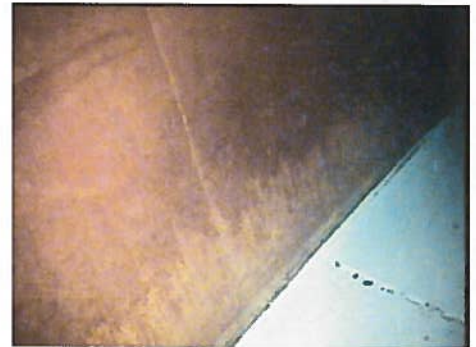
The interior shell was found to be in good condition with little to no discrepancies noted. The interior coating had no blemishes found. The shell plates are darker in color due to the sediment "iron & manganese" that have discolored the shell. There was a small amount of sediment collecting to the shell.

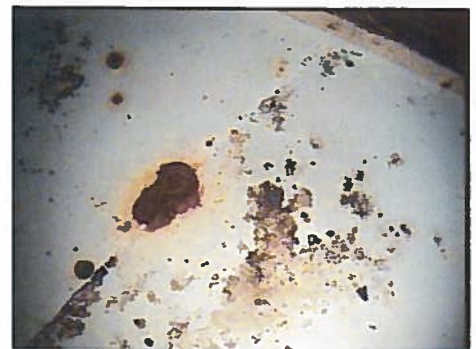
After bottom cleaning was conducted, random floor plate seams and floor to wall seams were visually inspected and exhibited good-fair coating adhesion; however several discrepancies found. There were many holidays found sporadically over the entire floor, most of which were quite large in size and have rust nodules built up indicating pitting of the steel is occurring. Also found was large pieces of rusted metal that are coming down from the roof trusses. For the most part the rust coming down from the roof is landing on top of the coating and not damaging the coating or the floor plates. However there are several areas where the rust coming down from the roof were large pieces and have damaged the coating and corrosion has started damaging the floor plates as well. Also found were a few questionable

areas where it appears blistering may be just starting. At the time of the inspection no blisters had actually formed with water or air behind them and obviously non had opened up or cracked. It did appear though that small areas of blistering may be forming, due to the roughness and small blister like bumps that are starting to form. Bottom sediment was on average a 1/4 of an inch deep over the entire floor. Divers removed the bottom sediment with an underwater vacuum system.

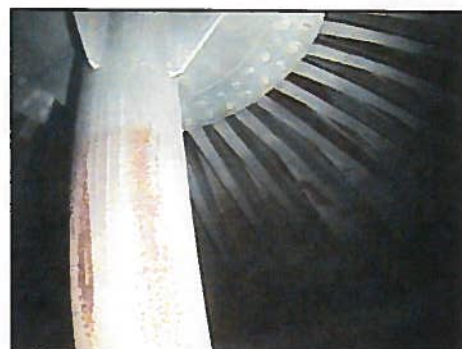
Support column supporting the roof was visually inspected with corrosion present on the column stem. The base plate and guides were in good condition with no problems noted. At the time of the inspection it did not appear the corrosion has yet pitted or compromised the integrity of the column. As the roof support column lower support structure is designed to move, there is always a concern about rust and corrosion within this area. No corrosion was noted around the base of the column during this inspection.

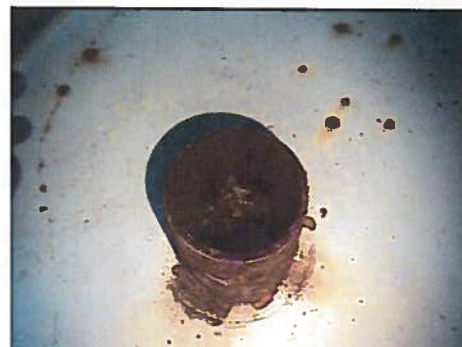
Overflow funnel and pipe appeared to be in good condition with some corrosion noted on the bottom of the pipe. The influent / effluent pipe had minor corrosion noted around the top edge and around the bottom floor weld. The man way entry was in fair condition with minor corrosion around the outer edges. The rubber seal did not show any signs of deterioration, weathering, or cracking. The interior ladder was in fair condition with some corrosion on the rungs where they are welded to the legs. The level indicator had one guide wire that was no longer attached to the anchor as it has corroded away. The other guide wire was in fair shape with corrosion noted. The float was in good condition and appeared to be functioning properly.

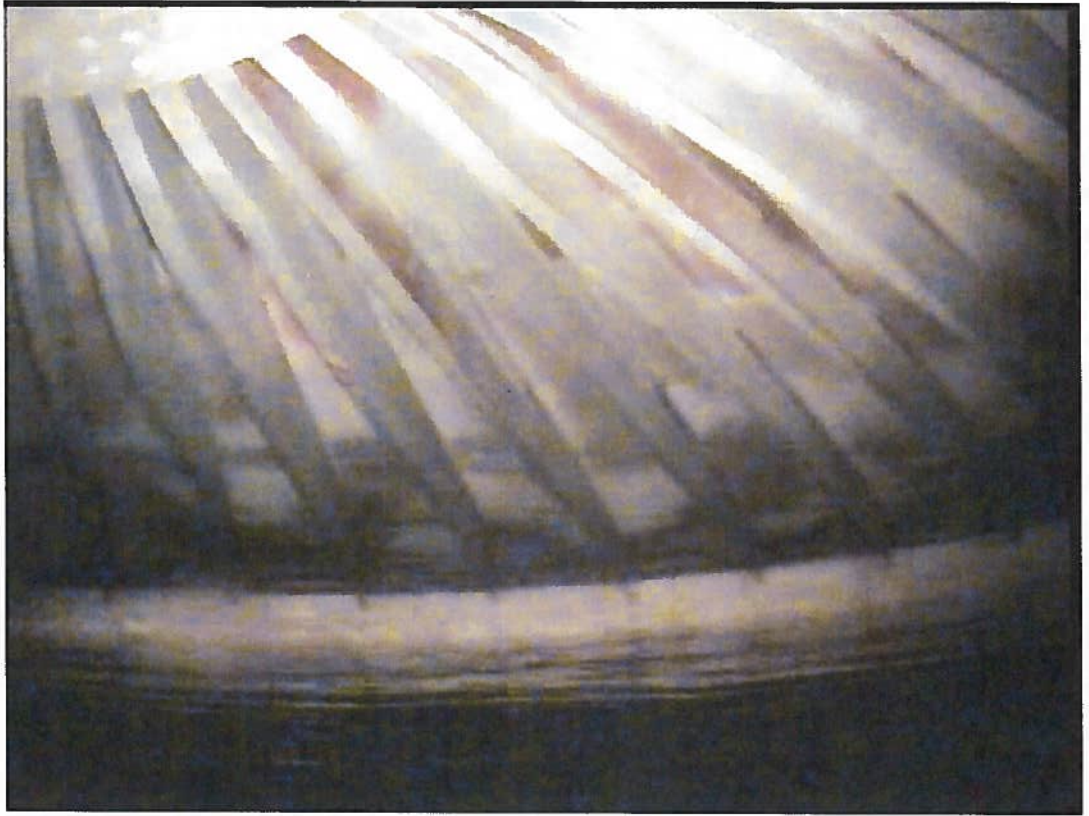
Corrosion  
truss
