Toledo Water Utilities
PO Box 220
860 Reservoir Lane
Toledo, OR 97391

DIVER INSPECTION REPORT

Ammon 1,000,000 Gallon On-Grade Steel-Welded

Inspection Date: 02-26-2024

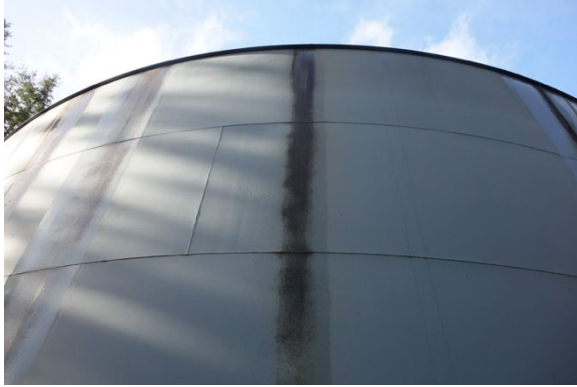
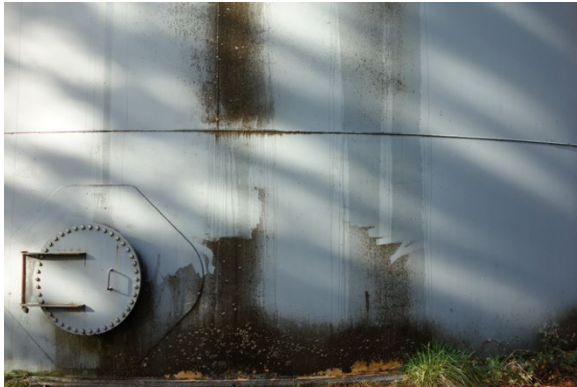
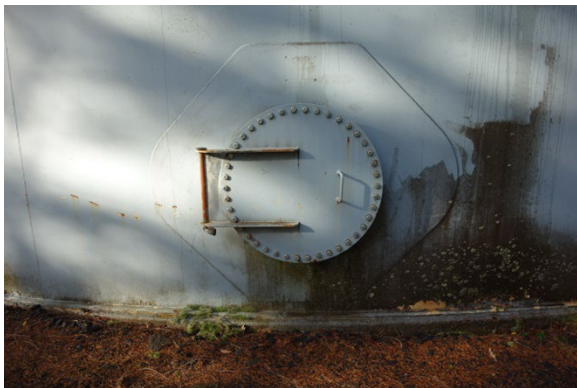
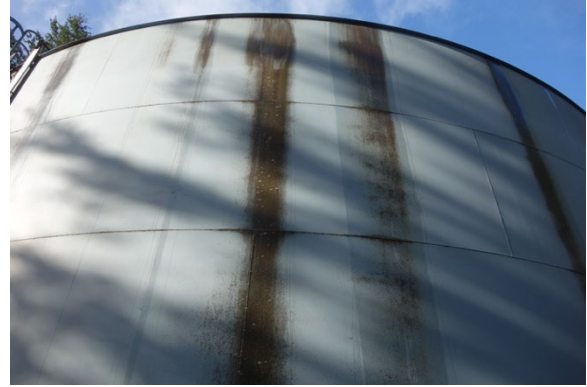
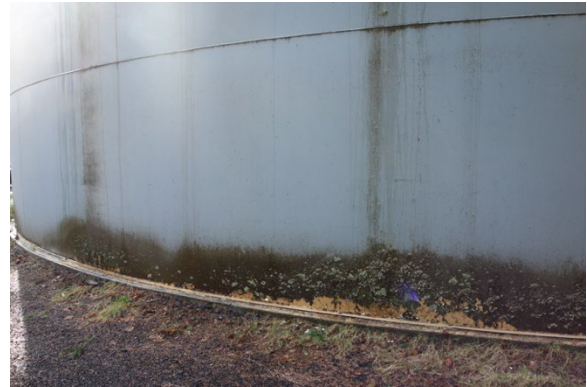
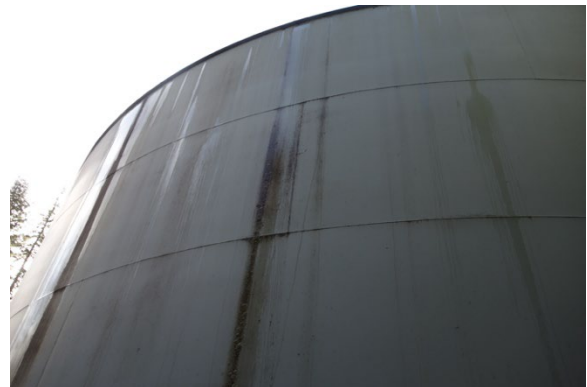
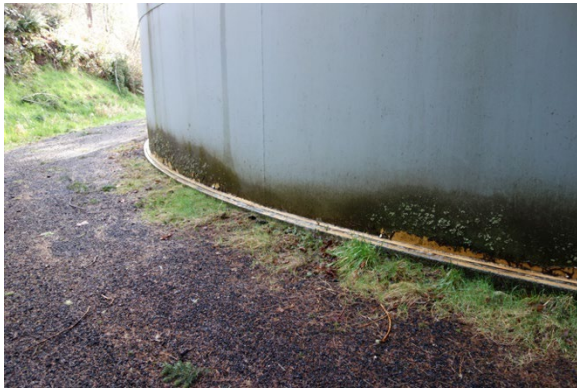
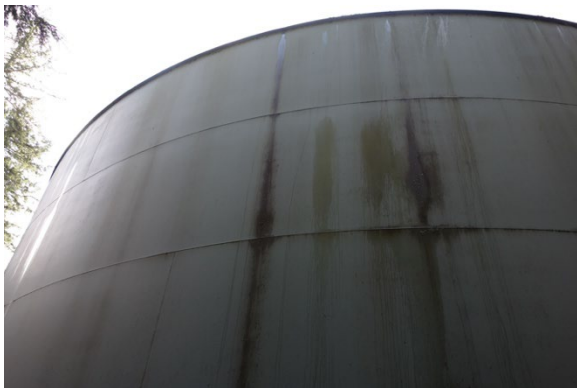
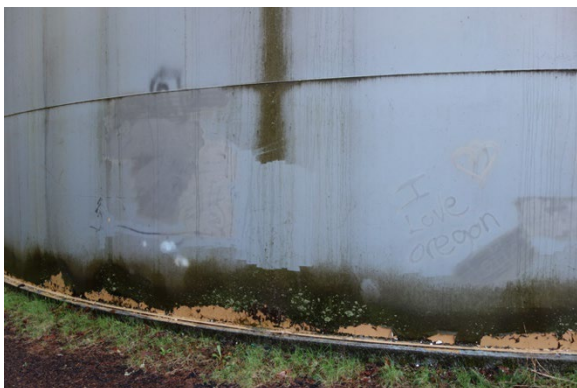
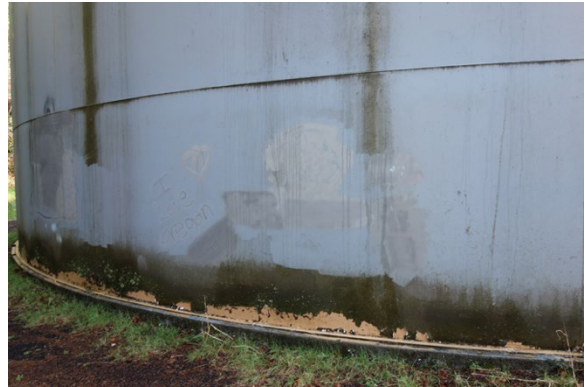
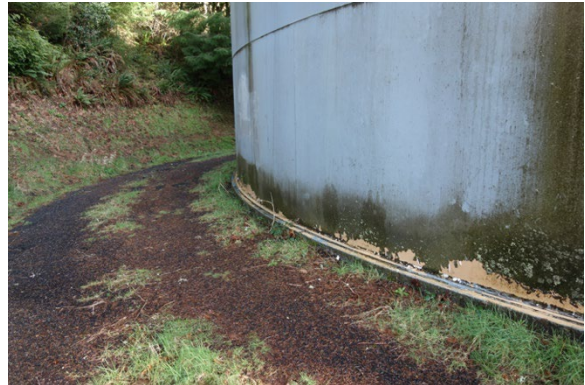
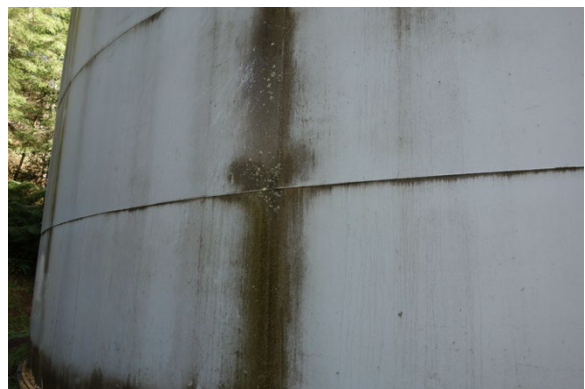
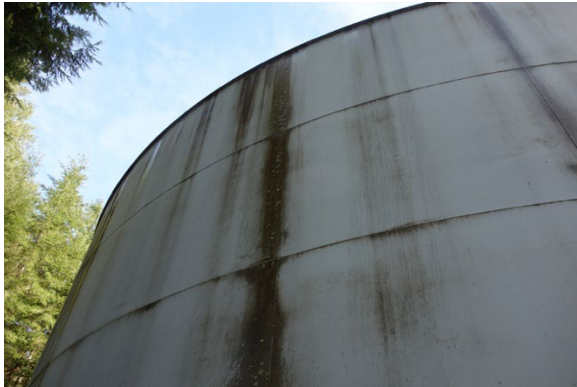
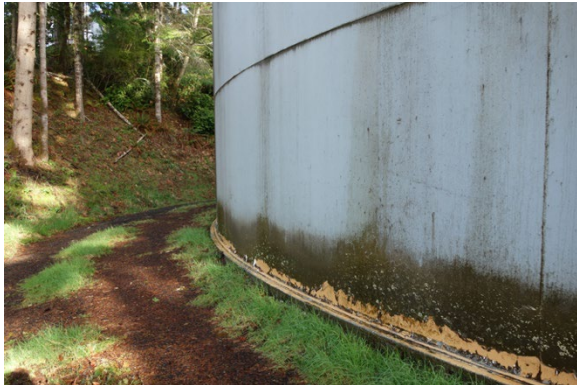
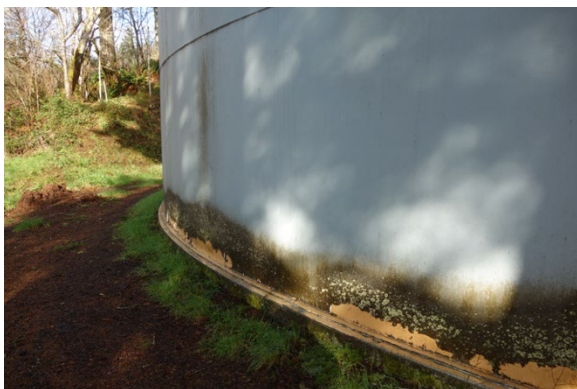
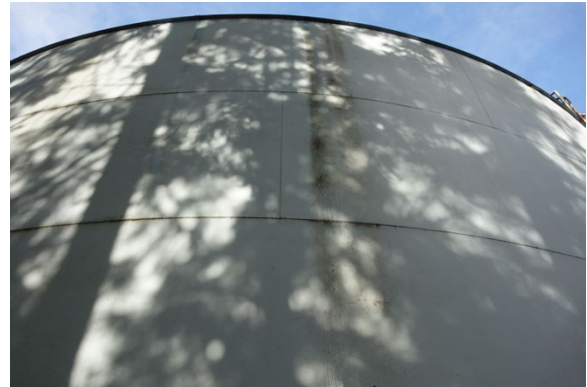
The exterior wall coating is in fair condition. It is flaking, peeling and shows vandalism in Q2 and Q3. See images #1-16. **Recommend full exterior recoat.**

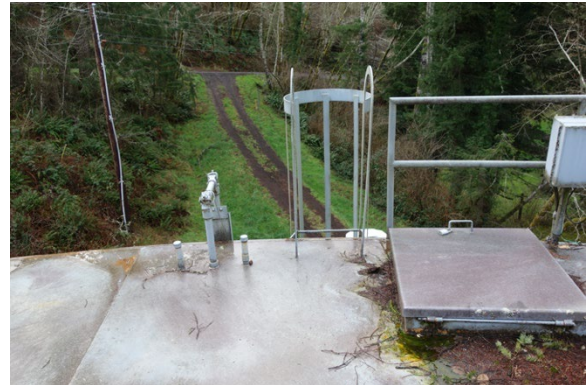
(#17) Exterior Ladder and Ladder Cage, Roof Penetrations, Roof Access Hatch, Exterior Electrical, and Roof Coating Condition

The roof coating is in fair condition. It is peeling paint and has damage from water puddling. There is some debris accumulation and bio-growth on the roof. **It is recommended to power wash the surface and provide area paint repairs.** See images #17-20.

Exterior ladder is in good condition without a lock on the ladder. A ladder cage is present. See image #17. **Recommend removing exterior ladder cage and installing a locking ladder security provision as per OSHA standards. See page 21.**

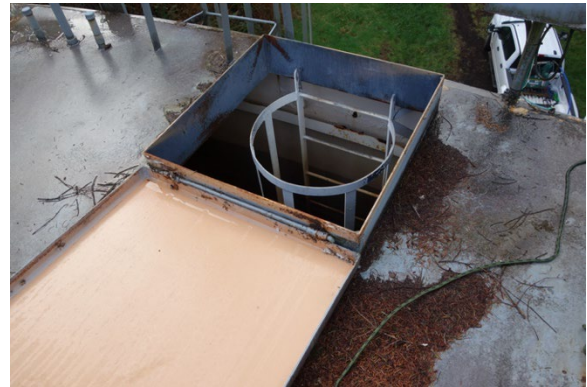
(#23) Roof Access Hatch Missing Gasket

Access hatch is in good condition with a lock. The access hatch is missing a gasket. See image #23.

Recommend installing roof access hatch gasket to meet watertight roof standards.

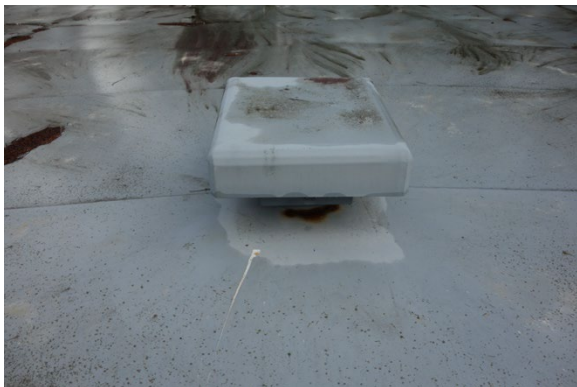
(#21) Roof Vent

The roof vent is in fair condition. See image #21.

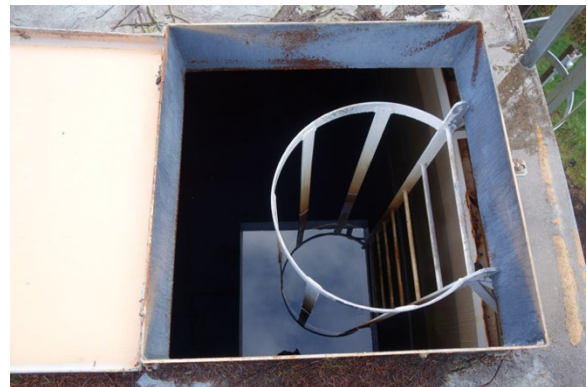
Ladder is in fair condition with a ladder cage present. See images #24 and 29-30. **Recommend spot repair to interior ladder and removing interior ladder cage as per OSHA standards. See page 21.**

(#24) Roof Access Hatch Interior and Interior Ladder with Ladder Cage

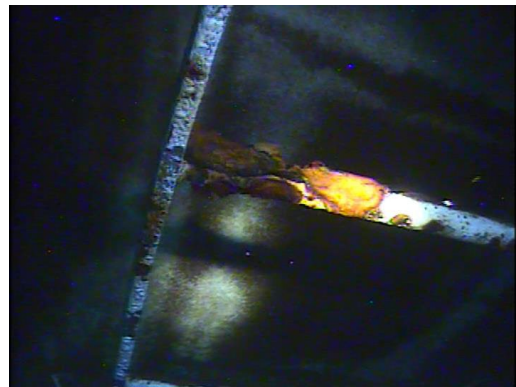
(#30) Interior Ladder Corrosion

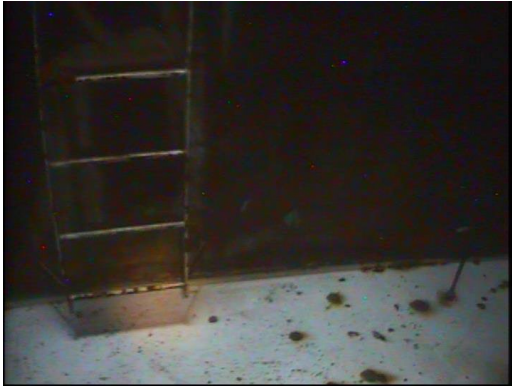
(#31) Interior Ladder Base and Floor Nodules

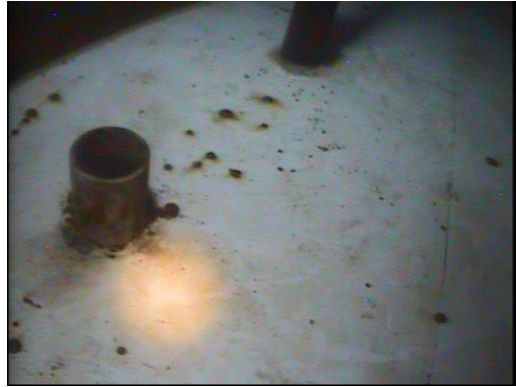
(#34) Inlet/Outlet with Silt Stop

The interior plumbing is in good condition with some coating failure observed. A silt stop is present. See image #34.

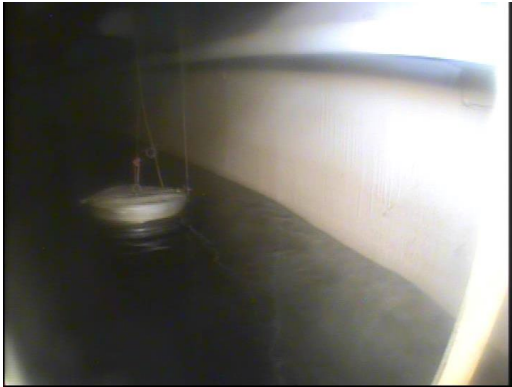
(#32) Float and Wires

Interior walls are in fair condition with areas of coating failure. See images #32 and 35. **Recommend spot epoxy repairs.**

The water level float and assembly are in poor condition. The float has a broken line. See images #32-33. **Recommend installing a new bracket and line for float.**

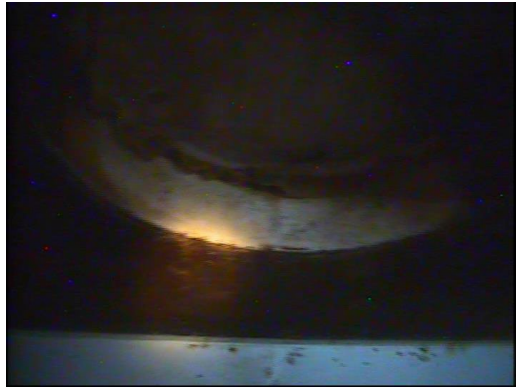
(#35) Interior Manway

Interior manway is in good condition, although the gasket is in fair condition. See image #35.

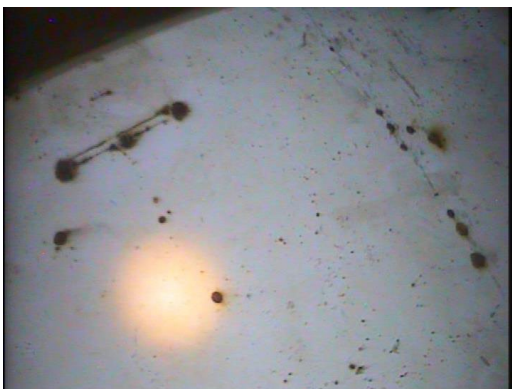
(#33) Float and Wire Guides Broken at Floor Attachment

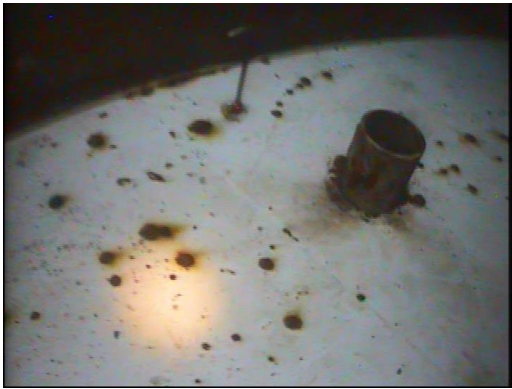
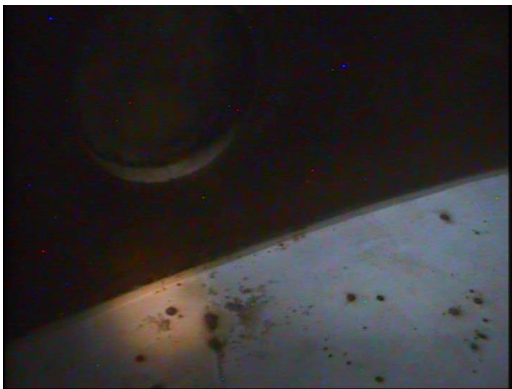
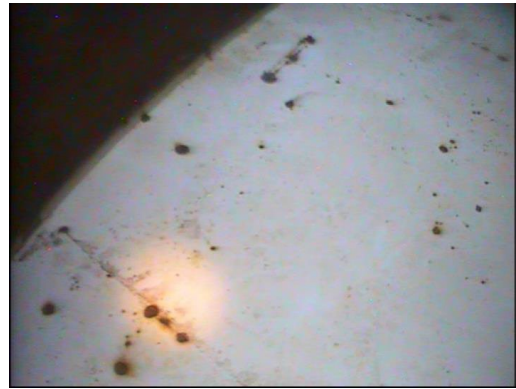
The tank floor is in poor condition with significant areas of corrosion nodules. See images #38-40. **Recommend immediate spot epoxy repairs.**

The interior floor showed heavy corrosion. Corrosion density was between 3 and 4 on the ASTM standard rating chart.
