City of Toledo

LINCOLN COUNTY, OREGON

Building Facilities Plan

April 2012

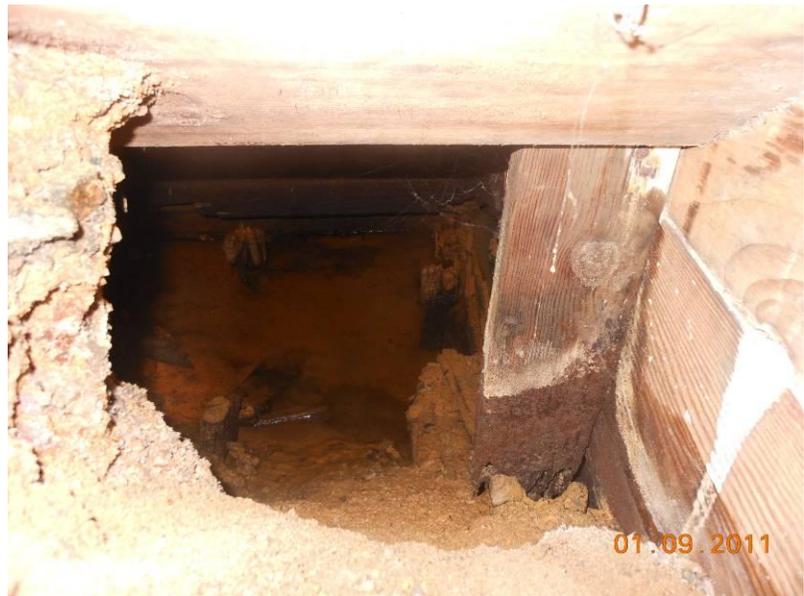
Figure 3.2.1.1A Basement Rot and Standing Water

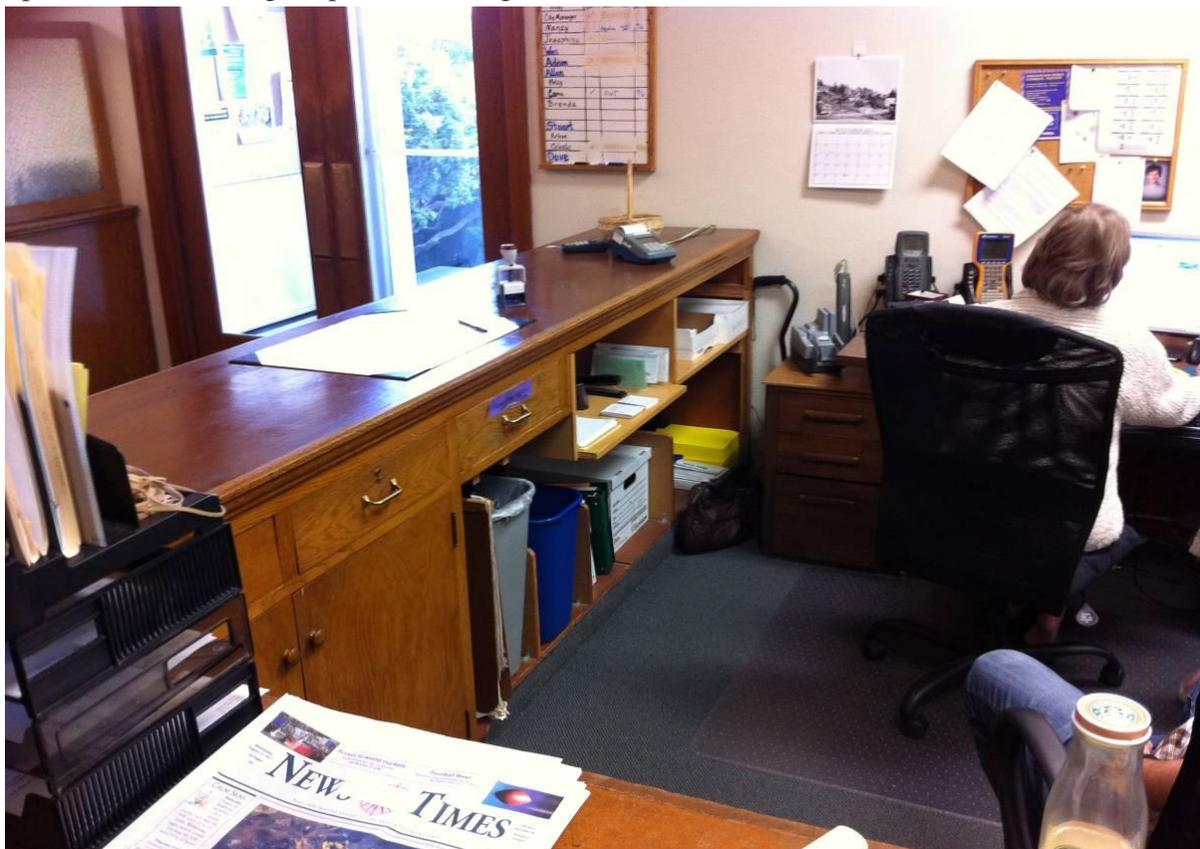
A significant deficiency exists in the lobby and public areas of City Hall. Considering the safety and security of City personnel, office staff have little to separate them from the general public. Generally, it is appropriate to have control routing, barriers, glass partition, high counters, and other obstacles to prevent the public from accessing the private working areas of staff.

Figure 3.2.1.1B Unprotected Front Desk Area

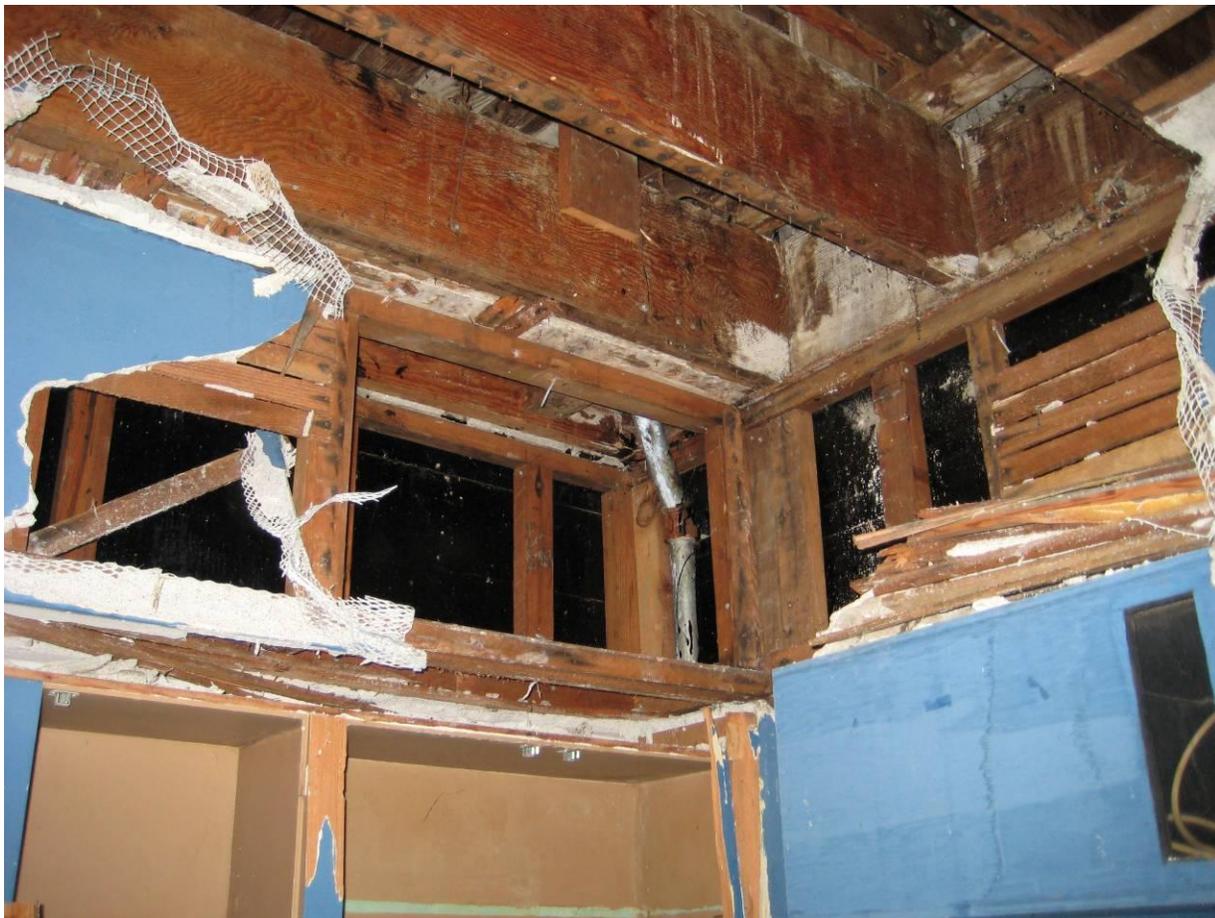
Figure 3.2.1.1C Extensive Water Damage

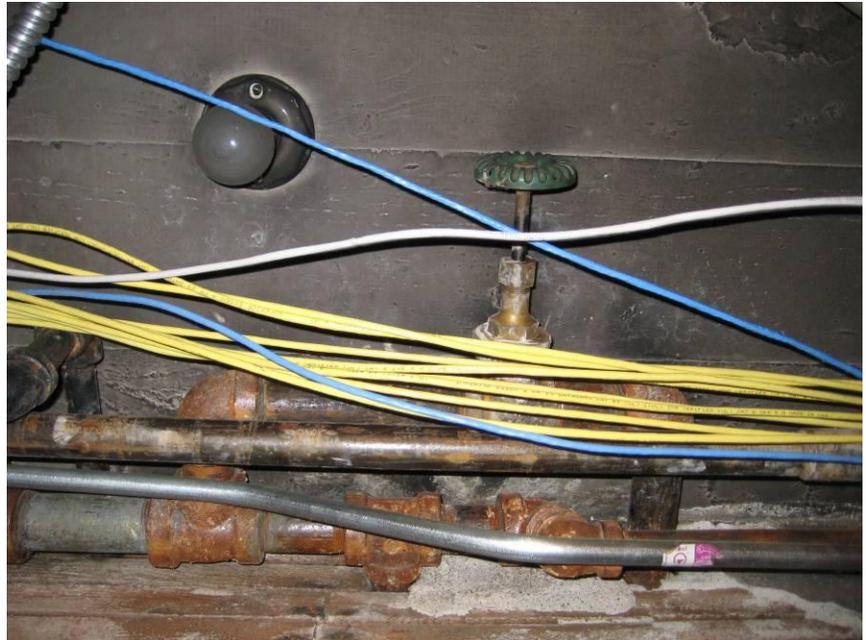
Open catch basin drains are located inside the building crawlspaces under the building. These catch basins receive water from the roof downspouts, which drain through the center of the building. The drains are deteriorating and are covered with temporary grates used as rodent barriers. As the roof is near the end of its life, it now pools water before draining into the downspouts.

Figure 3.2.1.2 Plumbing Corrosion

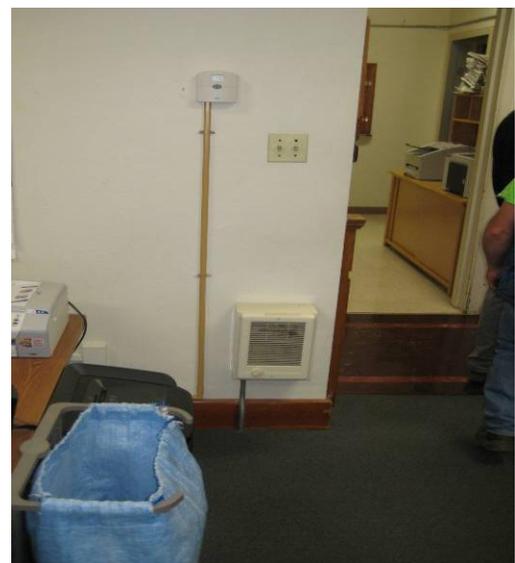
Energy efficiency at the site should be improved to lower heating requirements. Existing windows are not energy efficient. Insulation was observed to be both insufficient and absent in several locations.

Figure 3.2.1.3 Front Office Heater Controls

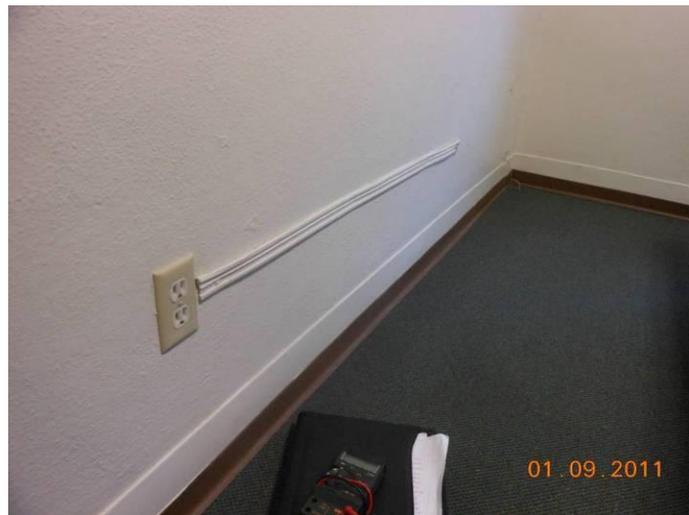
Lighting in the building is a mixture of fluorescent and incandescent fixtures. Like the structure of the site, lights are a patchwork of different remodels and retrofits with no consistency in fixture styles. Some of the offices have up-to-date illumination while the hallway corridors and basement areas do not. Pull chain style incandescent fixtures with exposed bulbs were observed in the basement and above the council chambers, which are not allowed by code.

Figure 3.2.1.4 Poor Wiring on Wall Surface

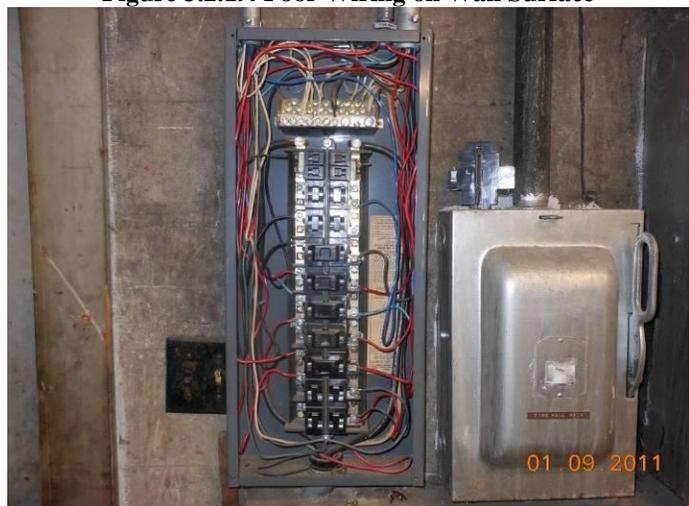
Figure 3.2.1.4B Outdated Pushomatic Basement Panel

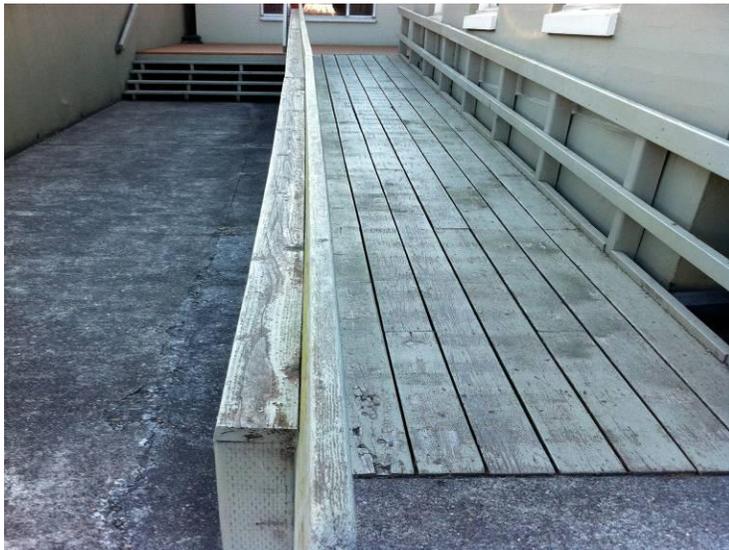
Figure 3.2.1.6 Unsealed Handicapped Ramp with Rot

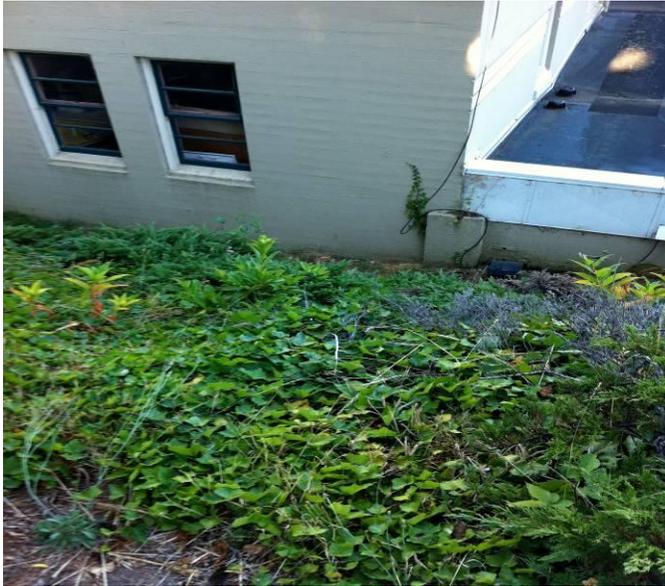
Landscaping attention is required around the building perimeter. Several shrubs and arborvitae trees are growing too close to the building causing damage to the exterior walls.

Figure 3.2.1.7 Landscaping work required

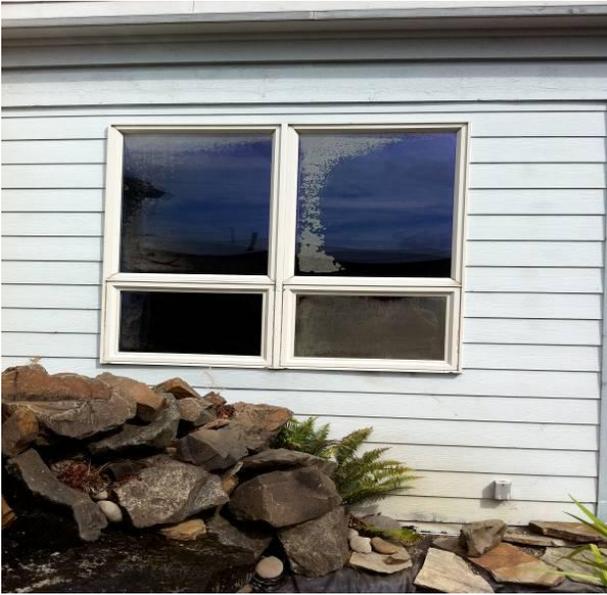
Figure 3.2.2.1A Fogging in Windows

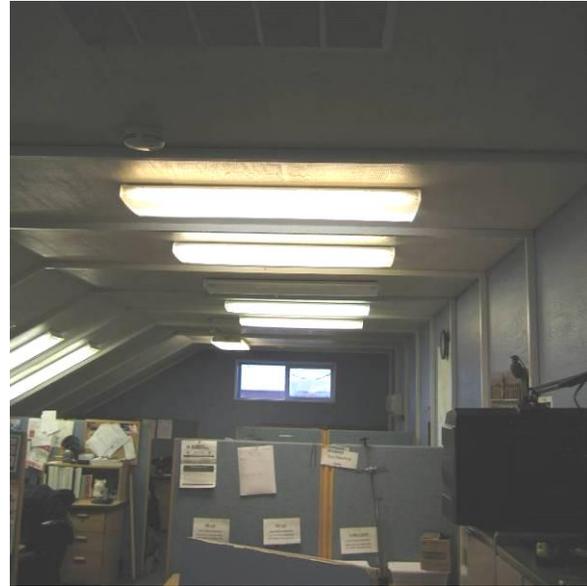
Figure 3.2.2.1B Crowded Police Offices Upstairs

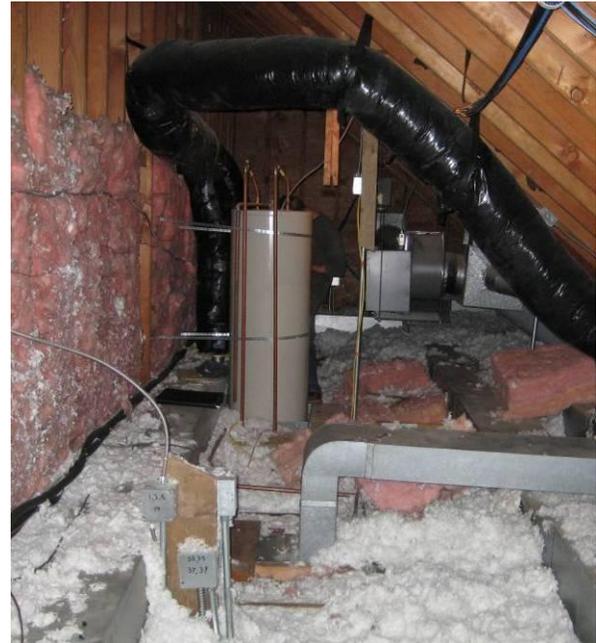
Water supply piping in the building was observed to be copper pipe. The drain piping was observed to be schedule 40 PVC. Plumbing deficiencies in the police station were limited to minor maintenance issues. The copper water supply pipe insulation is deteriorating and missing in some locations. There are some running toilets inside the building. No deficiencies were noted in the drain systems of the building.

Figure 3.2.2.2 Uninsulated Water Pipes

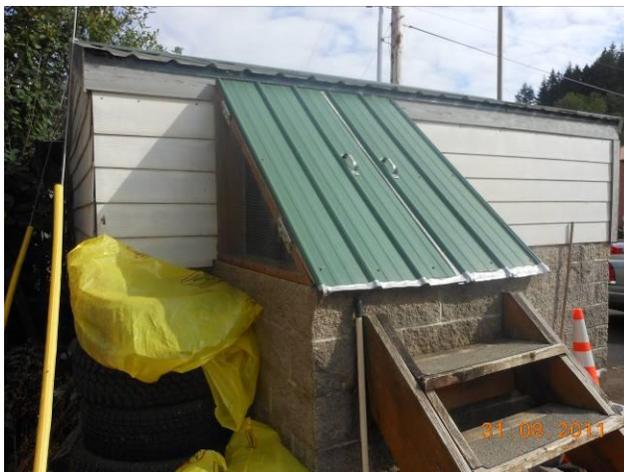
Figure 3.2.2.4 Poor Generator Building Access

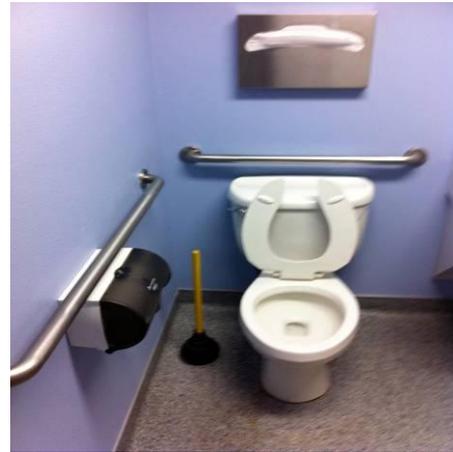
The building sits down a gentle slope from the adjacent highway. The main entrance is at-grade and there is a direct route to the ADA parking stalls. Most of the activity at the police station is on the main floor, with cubicles and storage lockers for the officers upstairs in the bonus room. The main floor has one accessible unisex restroom facility. A list of ADA code violations can be found in Table 3.2.2.8

Figure 3.2.2.6 Handicapped Stall, Toilet does not meet sizing Requirements

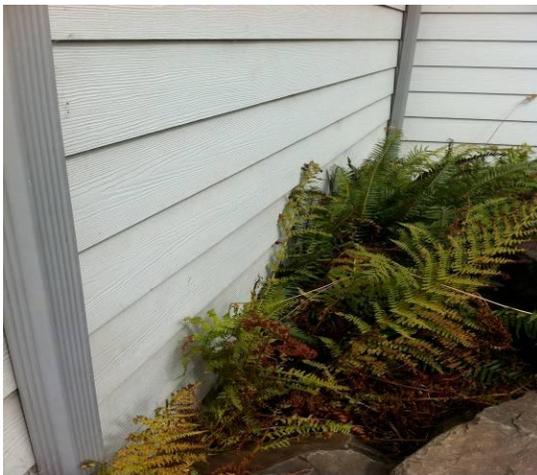
Figure 3.2.2.7A Remove Foliage

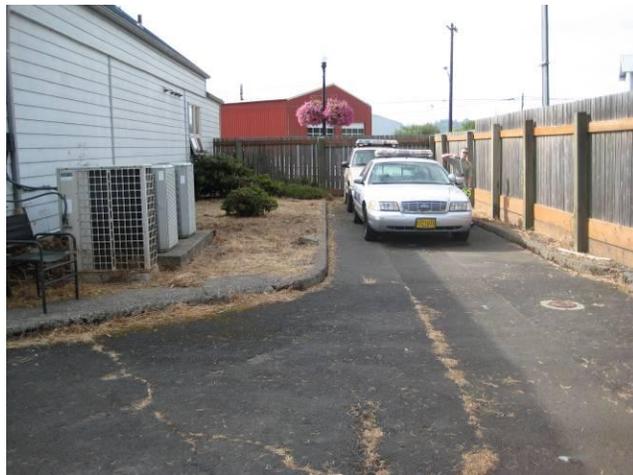
Figure 3.2.2.7B Poor Parking Behind Building

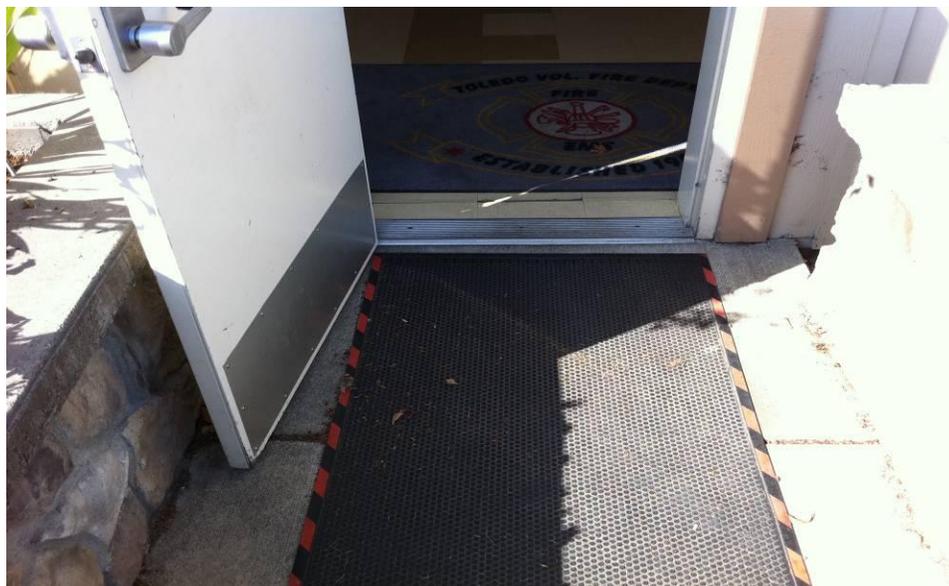
The front entrance has water damage from an improper sidewalk slope. Several floor tiles need replaced and a drain installed in the sidewalk.

Figure 3.2.3.1 Front Entrance Water Damage

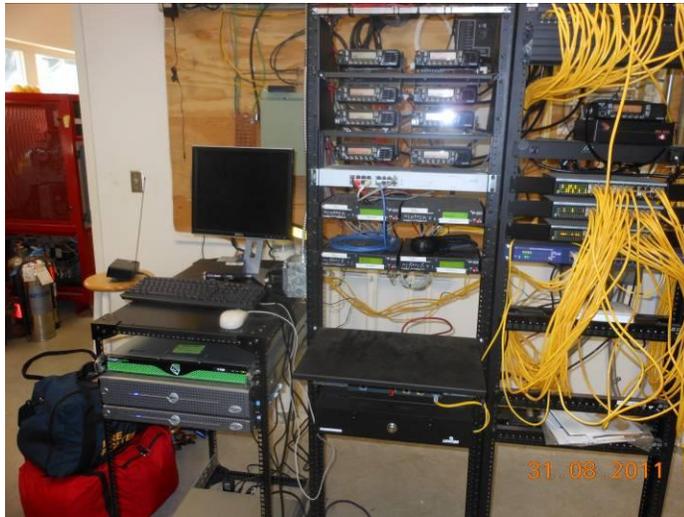
Natural gas forced air heat is used to condition the fire station. No A/C or cooling system is present in the building. The attic rafters are insulated, however the ceiling is not. The large attic conditioned space creates additional unnecessary heating demands.

Figure 3.2.3.3 Un-cooled Electronics

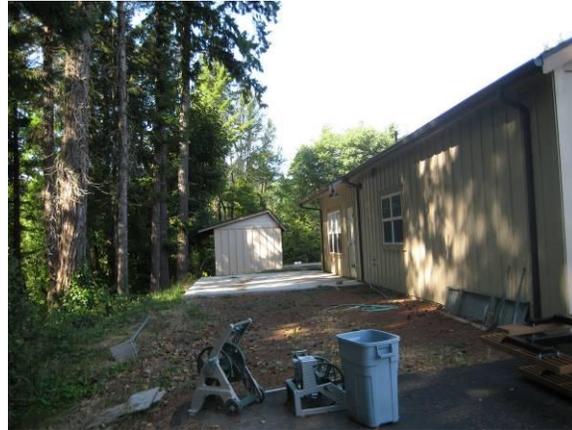
Other than the sidewalk sloping into the front door, the site is in good condition. The site is provided with ample parking. The fire station is considered an essential facility which must continue to operate during an emergency or natural disaster. The City reports trees around the building are causing damage from falling limbs and debris.

Figure 3.2.3.7 Tall Trees near Building

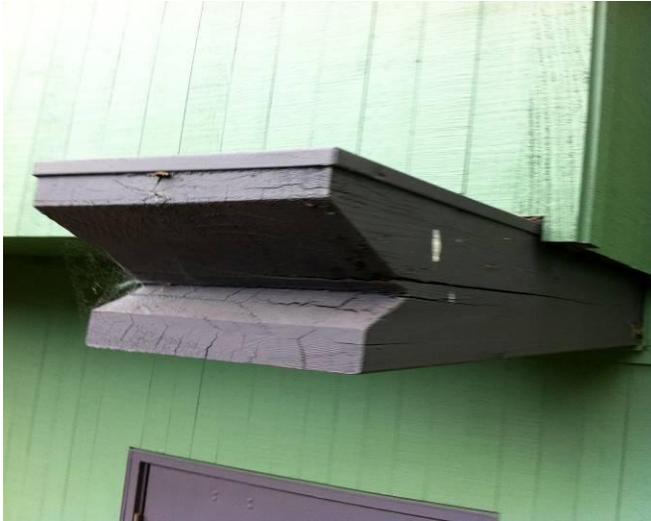
The exterior siding and exposed beam-ends have visible rot which can easily be repaired. A wood fence on the south side of the building is leaning and rotted. The suspended ceilings inside the building are not braced and many ceiling tiles are discolored.

Figure 3.2.4.1A Trim Rotting Beam

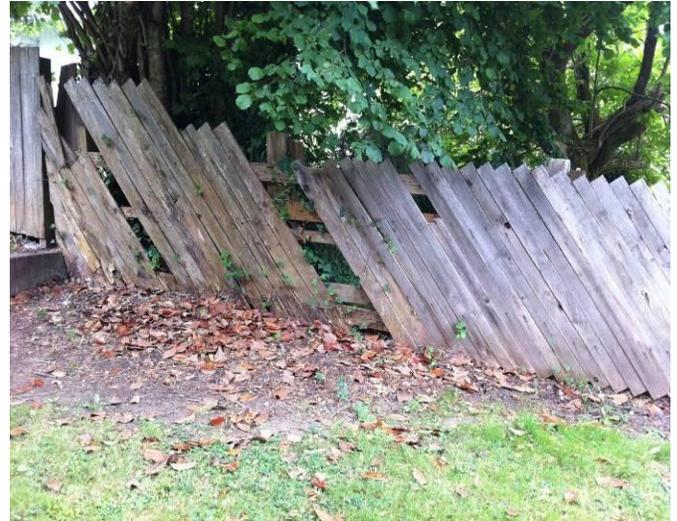
Figure 3.2.4.1B Fence is Defunct

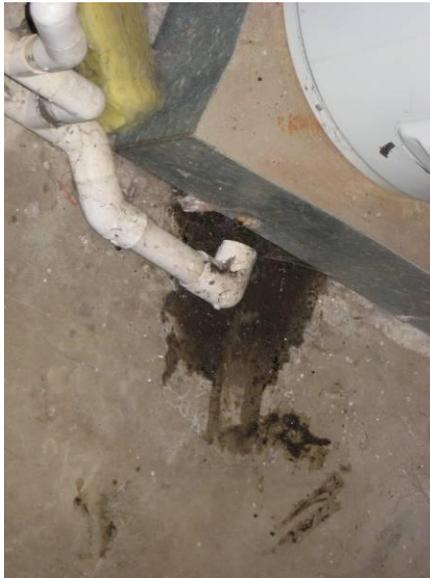
The library plumbing conforms to the standards in place at the time it was constructed and is in typical condition for its age. The interior plumbing does not need any major attention. On the exterior, the gutter downspouts are misaligned with their catch basins. Some of these catch basins need cleaned out. The water heater drain pan upstairs is leaking because it is not attached to its drain pipe.

Figure 3.2.4.2A Water Heater Pan Disconnected

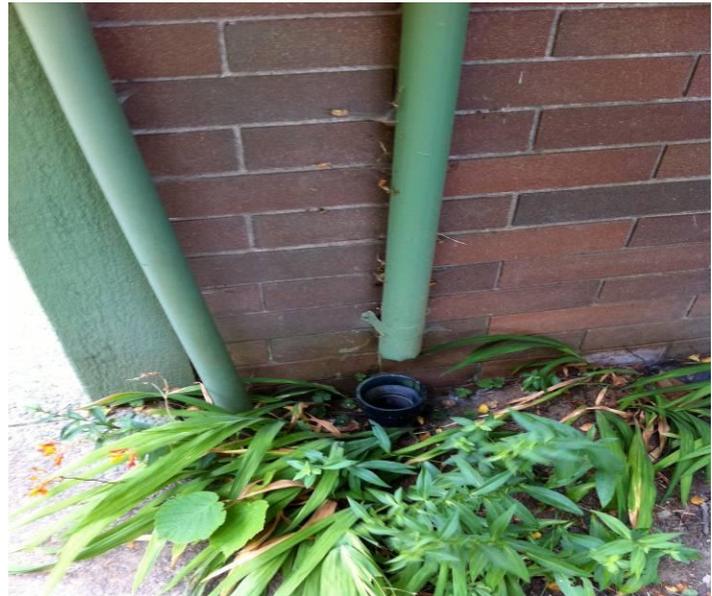
Figure 3.2.4.2B Downspouts Misaligned with Drains

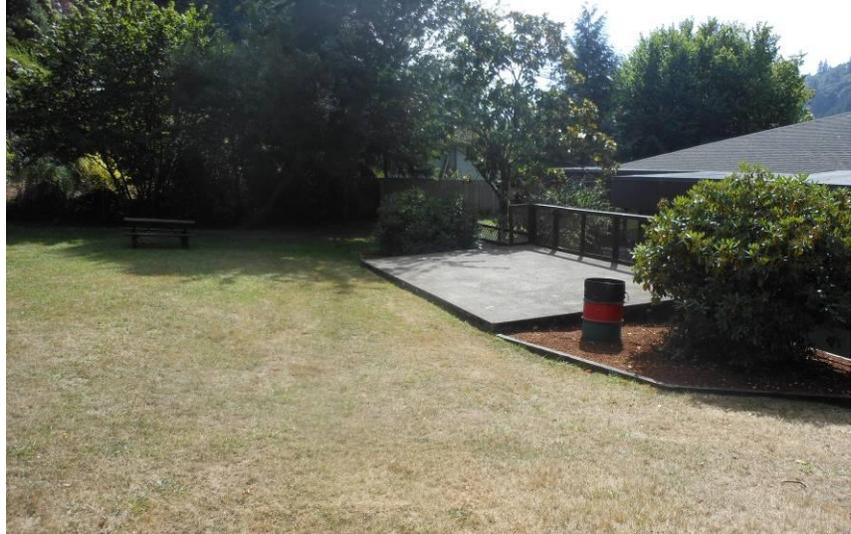
Electrical power to the library is provided by a 600 amp 120/240V single phase service. The main service panels are in good condition and are sized to power the loading of the lighting and climate control required by the building. Lighting is good in the building but it was noted that there is limited egress lighting visible for night hours. There was observed to be only a limited number of floor receptacle circuits available for future computer expansion. The outside stage area contains an outdoor circuit which needs replacement due to corrosion.

Figure 3.2.4.4 Stage Area & Retaining Wall where Circuits need Replaced

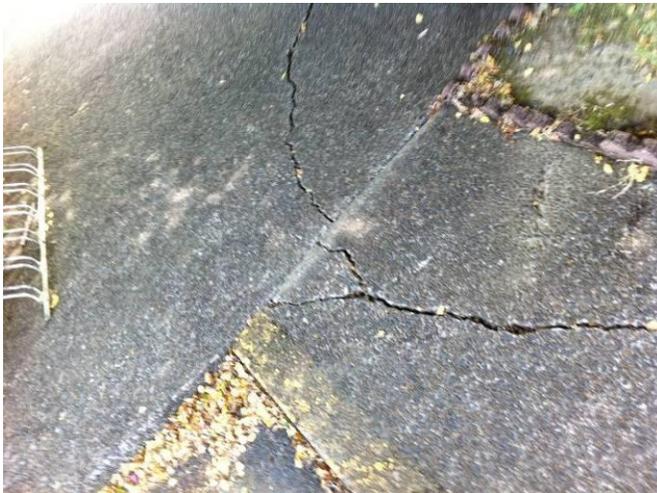
Parking is positioned to the east of the library and is poorly arranged. The parking lot is broken up with many partitions and large trees. Parking spaces therefore are constricted and space inefficient. Removing the trees and partitions would free up additional and wider spaces. The sidewalks to the building, from the parking lot, are cracking and breaking from the tree roots. The concrete appears to be original to the building construction.

Figure 3.2.4.7A Sidewalk Cracking

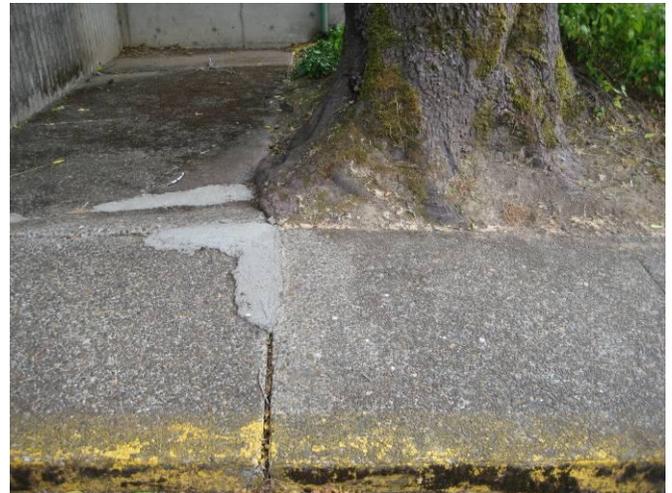
Figure 3.2.4.7B Tree Roots Intruding

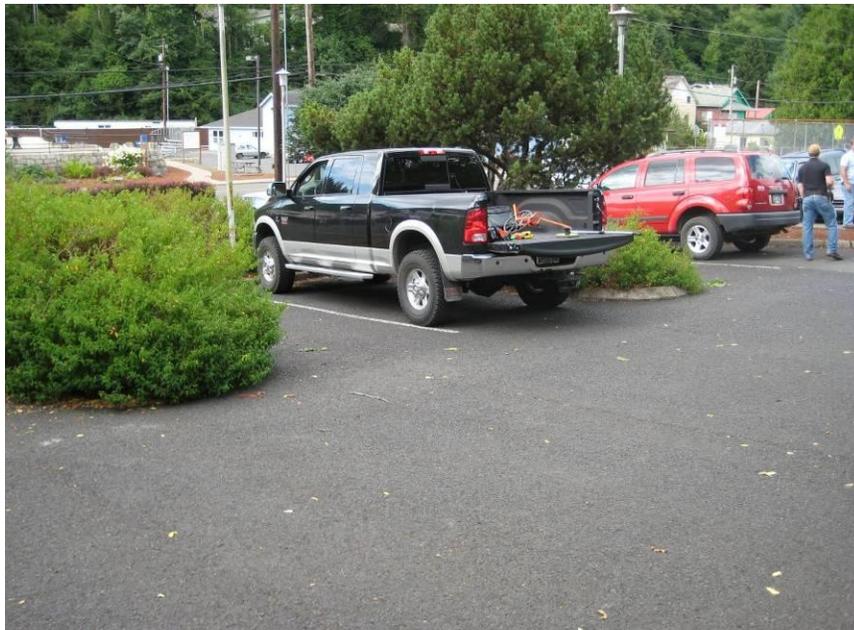
Figure 3.2.4.7C Parking Islands and Foliage Reducing Available Parking

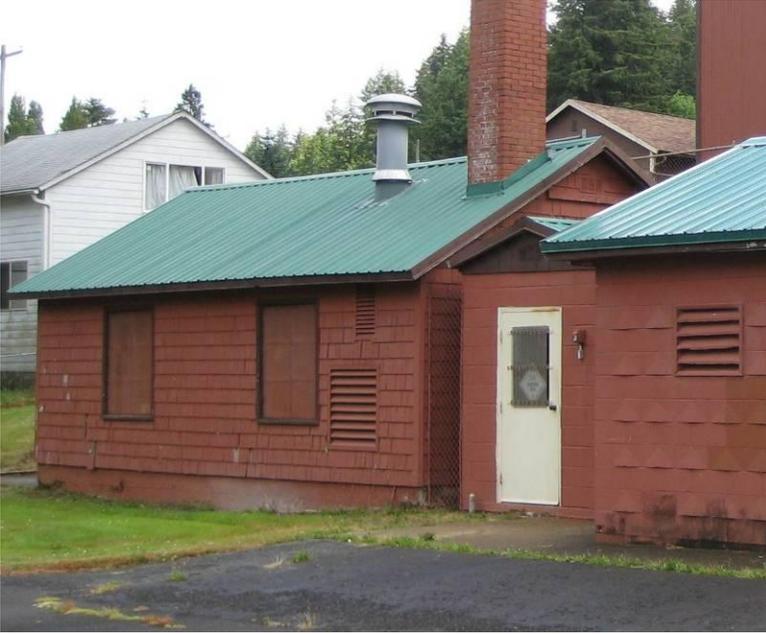
Extensive rot is present on both the main building siding and the pump/filter outbuilding. The protective exterior paint layers are peeling off the building and exposing bare wood. The composition sloped roof and flat roof are near their end of life and require replacement soon. Interior work is needed in the area of trim and paint. The pool structure is cracked. The cracks appear to be dated and not contributing to leakage which would be indicative of future pool failure. Various seismic detailing issues exist related to the CMU wall and timber roof systems.

Figure 3.2.5.1A Pump and Filter Building

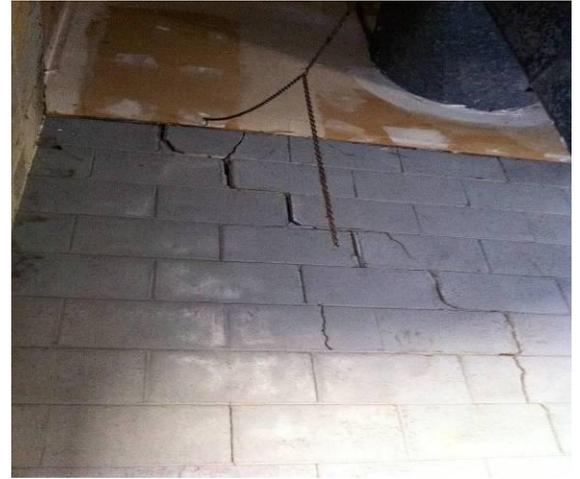
Figure 3.2.5.1B CMU Wall Cracks

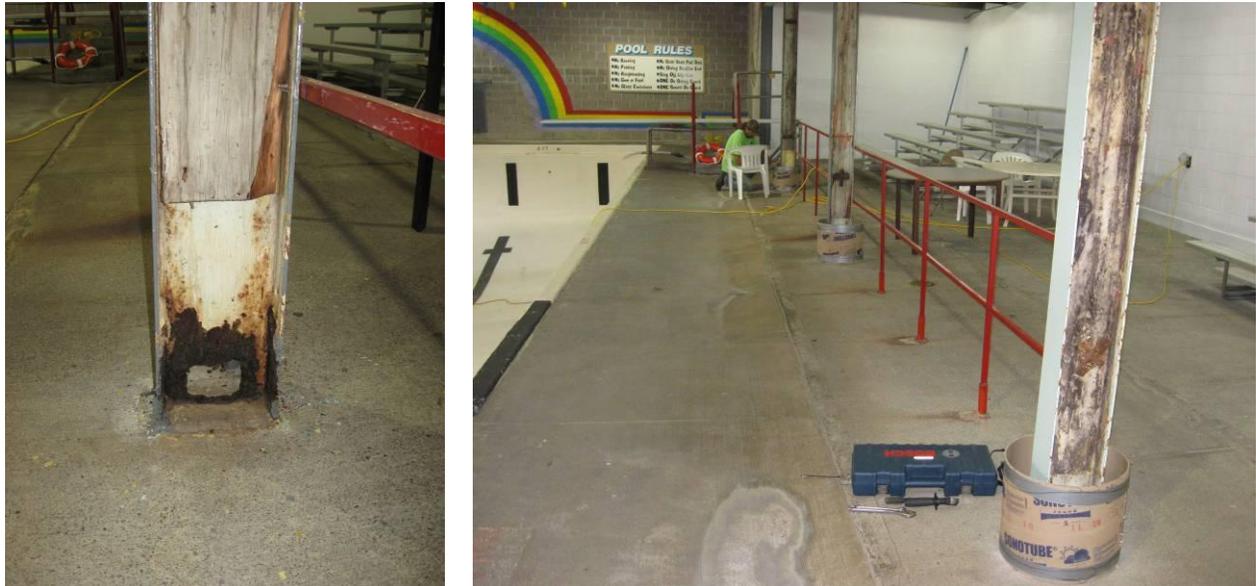
In September of 2011, several steel columns supporting the roof structure had to be repaired. The connections to the floor were extremely corroded. A concrete collar was poured around the columns to stop the corrosion and reinforce the floor connections. The collars may not stop the corrosion but will provide additional stability to the structure. A permanent floor connection will eventually be required.

Figure 3.2.5.1D Pool Column Repairs Completed September 2011

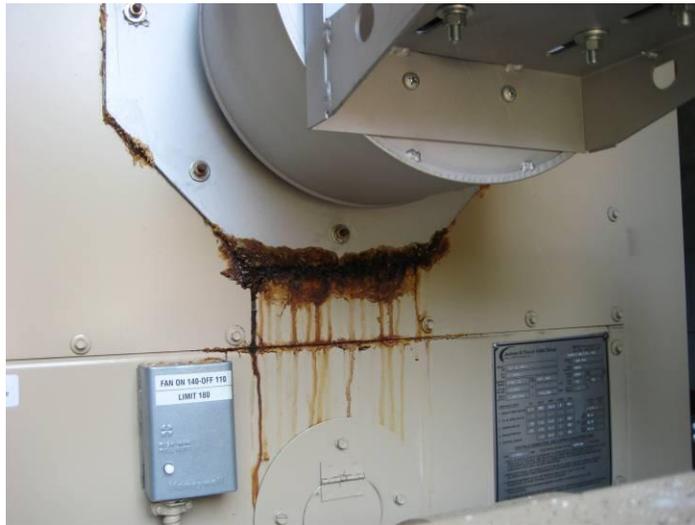
Significant deficiencies exist in the ventilation system. Humidity control is non-functional and has been for many years. The pool staff opens doorways to manually ventilate the building. Only the heating system is functional. The ventilators on the roof and the heat recovery dehumidification system do not function. The building heater was replaced in 2009 with a new gas furnace that is already experiencing corrosion. The portion of the building enclosing the furnace is not providing adequate moisture protection.

Figure 3.2.5.3 New Furnace Corrosion Evident

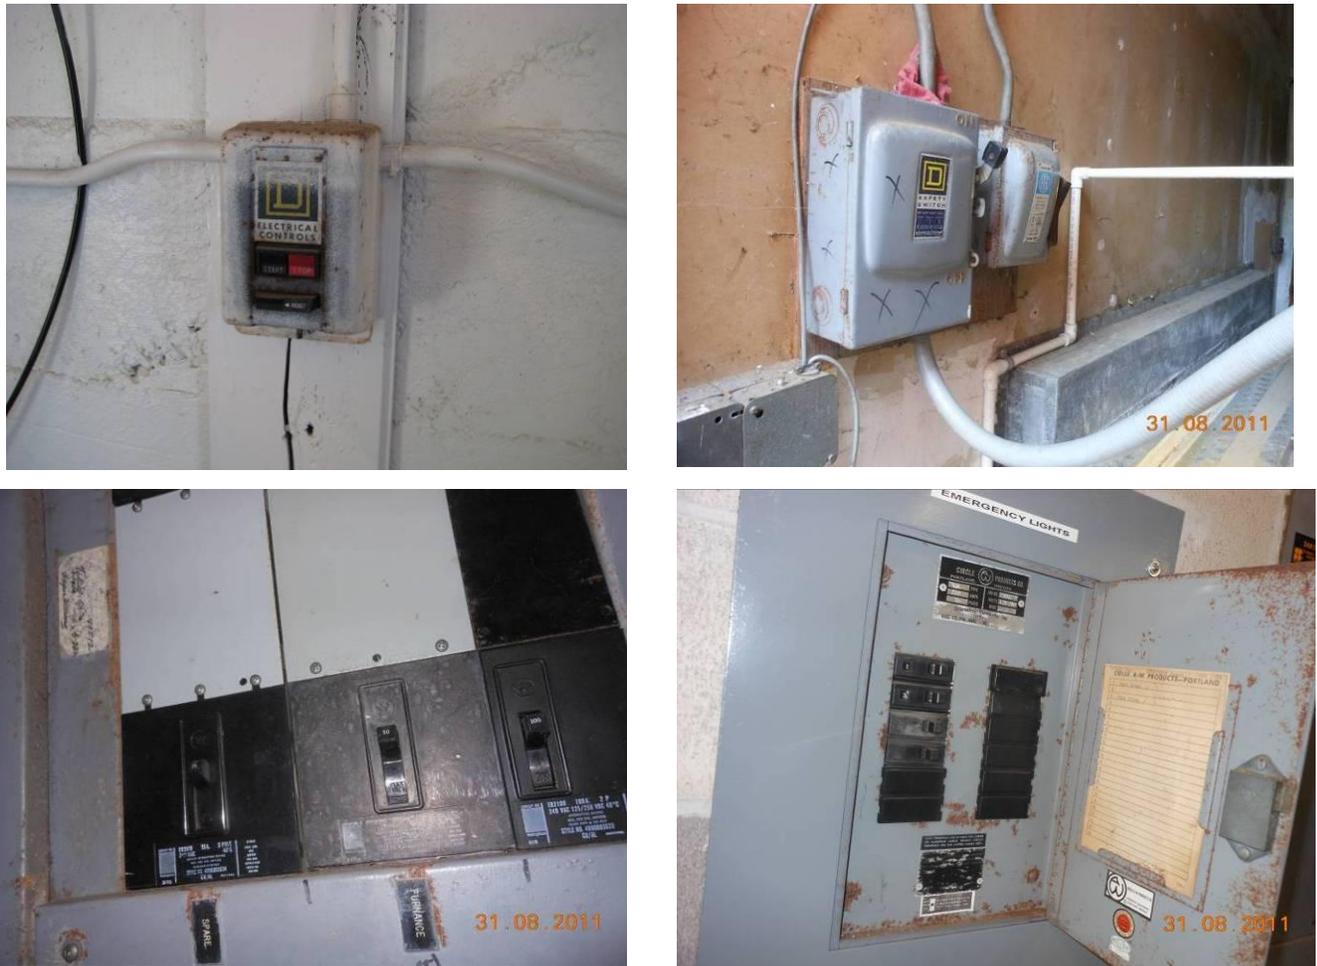
Portions of the lighting and receptacles have been updated with GFI protection and sealed fixtures. These fixtures can continue to be used safely. Attention is needed in the pump and filter building, where better safety lockouts are needed on the vacuum system. The controls to the heating, ventilation, and pumps are out-dated, manually run, and contain some corrosion.

Figure 3.2.5.4 Extensive Electrical Corrosion and Outdated Panels

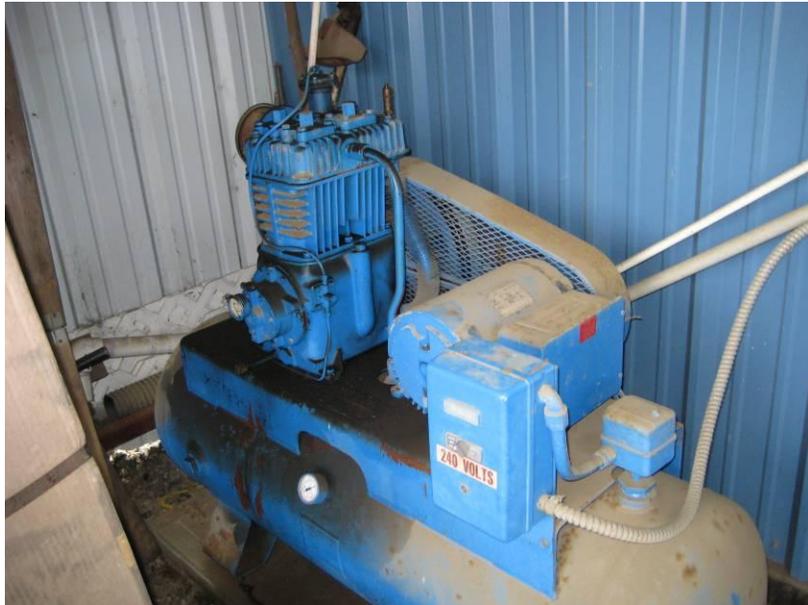
The air compressor is due for replacement. Air piping from the compressor is missing a condensate drain. No other deficiencies were observed in the air piping distribution network.

Figure 3.2.6.3 Old Air Compressor

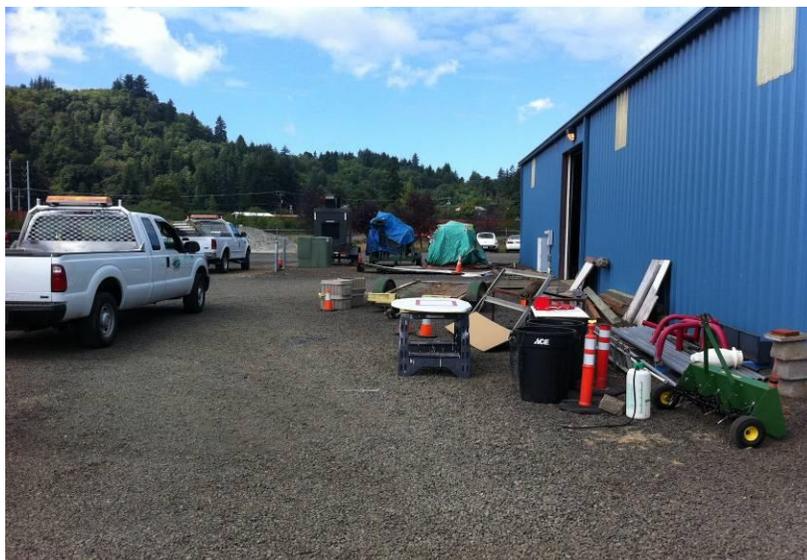
Figure 3.2.6.7 Additional Storage Needed

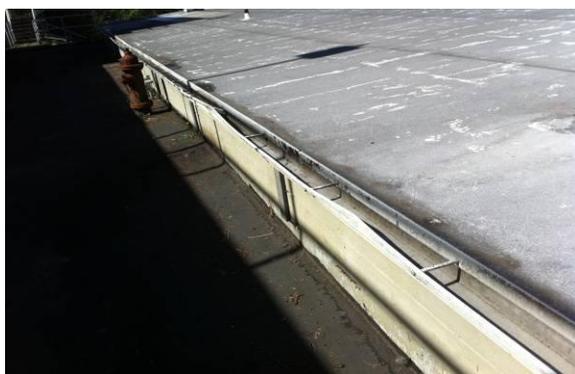
Figure 3.2.7.1 Roof and Gutter Repairs

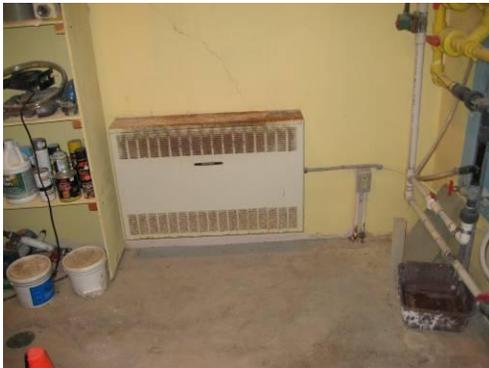
Figure 3.2.7.3 Rusted Heater

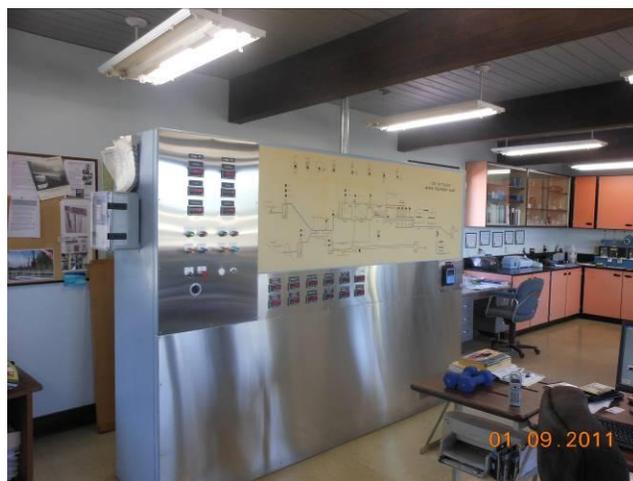
Figure 3.2.7.4 Control Panel and Dialer, Only Partial Lighting Used

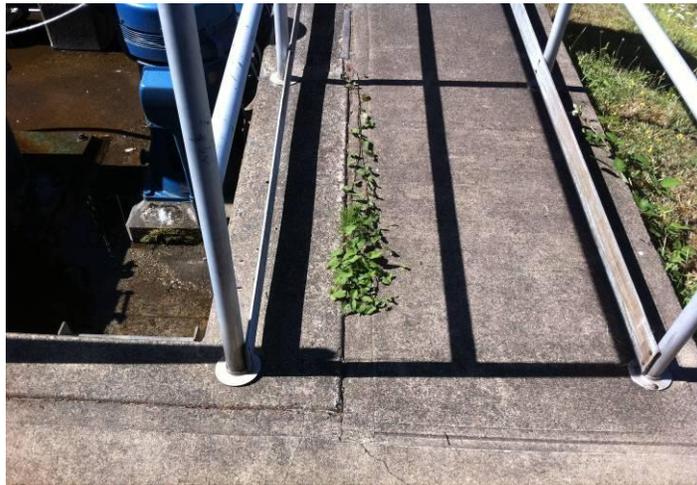
Figure 3.2.7.7 Minor Foliage Problems, Spray and Remove

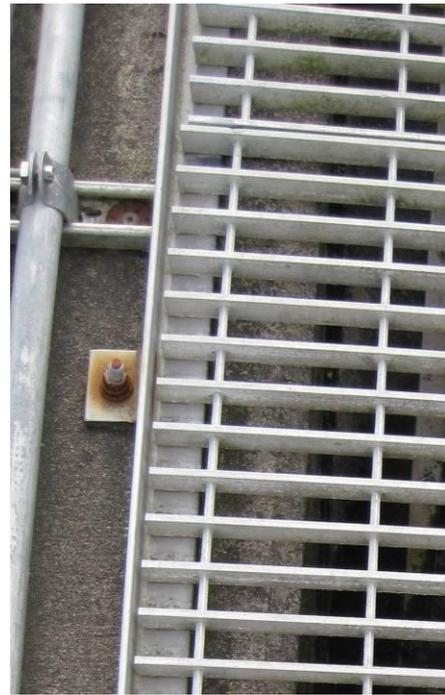
Figure 3.2.8.1 Un-galvanized Anchor

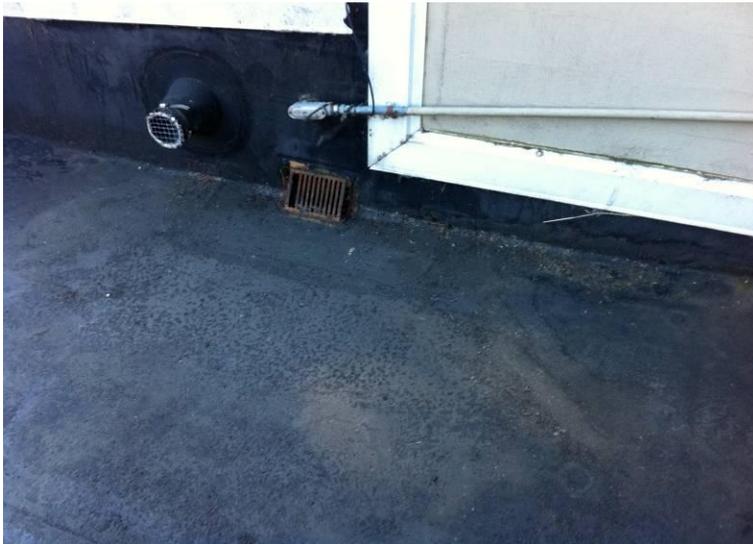
Figure 3.2.8.4 Conduit Blocking Doorway
