Structural Evaluation for the Toledo Swimming Pool

Prepared for:
City of Toledo
&
Young Design Studio

October, 2014

Subject: Structural Evaluation

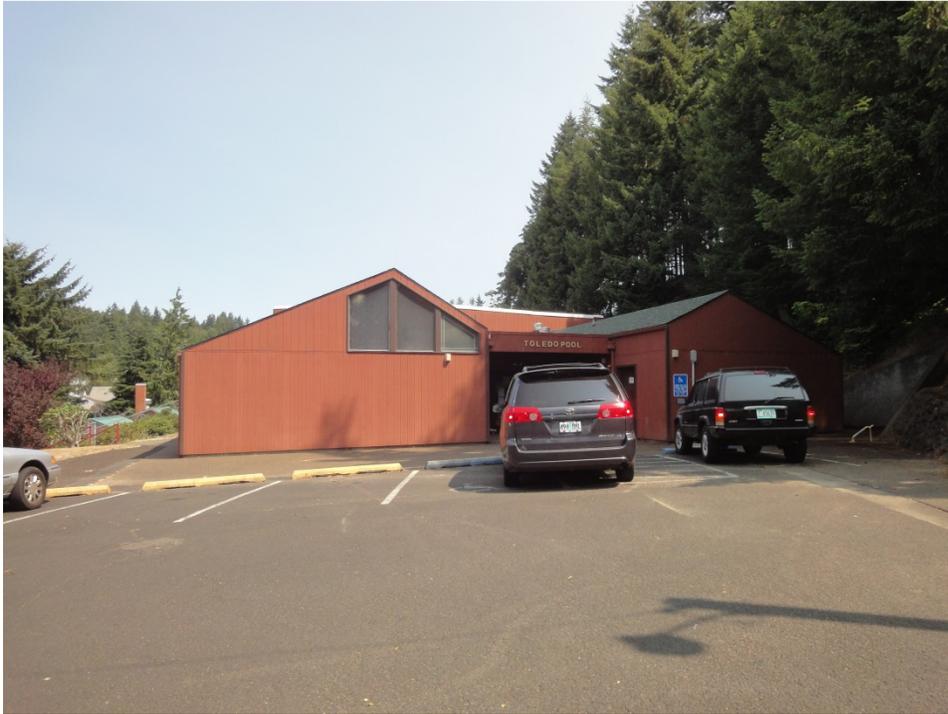
Figure 1 – North Exterior Elevation

ZCS was tasked with evaluating the lateral and gravity force resisting systems of the Toledo Swimming Pool facility (Figure 1). The structural elements of the building are described below.
