# City of Toledo Oregon FIELD REPORT

July 14, 2011

**Underwater Cleaning and Inspection  
Ammon Road Tank  
1,000,000 Gallon  
Potable Water Storage Tank**

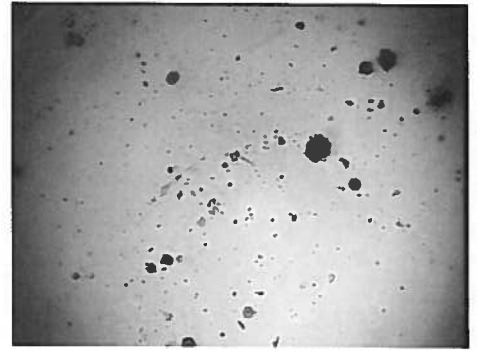
2. The exterior roof coating around the outer edges has corrosion present where the water collects and has damaged the coating. These areas will need to be touched up regularly as the tank only has one support column in the middle and the outer edges are sunk in a little.
3. The interior coating is near the end of its useful service life and will need to be replaced in the near future. Many areas have failed and rust nodules have begun indicating pitting of the steel plates has started. Also found were large pieces of metal coming from the interior roof, these pieces of metal have landed on the coating and in some cases have damaged the coating.

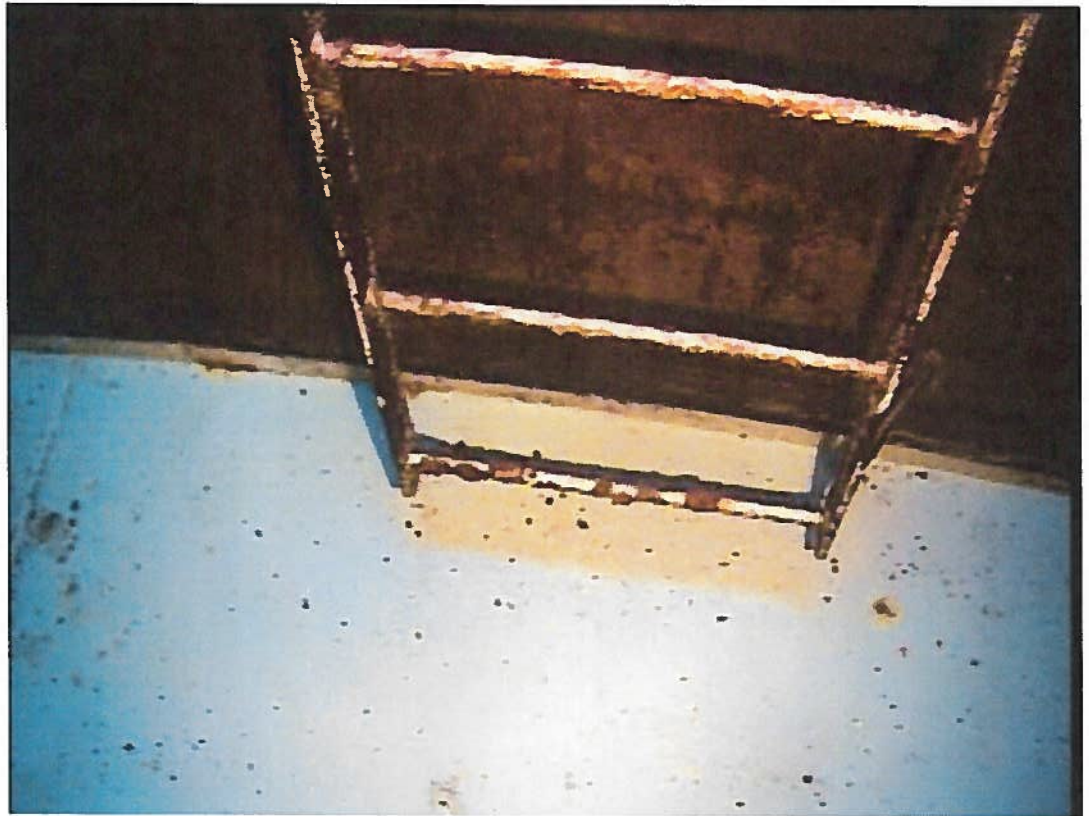
ladder

Periodic Protection	<u>none</u>	Ladder	<u>corrosion on rungs</u>
Interior Plumbing	<u>slight corrosion</u>	Clean-Outs	<u>none</u>
Water Level Sensors	<u>good</u>	Overflow	<u>good</u>
