Toledo Water Utilities
PO Box 220
860 Reservoir Lane
Toledo, OR 97391

DIVER INSPECTION REPORT

Ammon 1,000,000 Gallon On-Grade Steel-Welded

Inspection Date: 02-26-2024

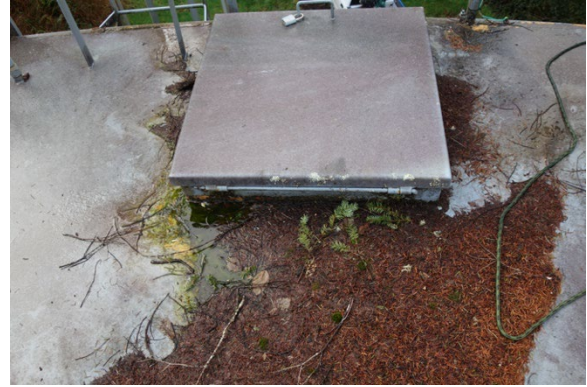
(#22) Roof Access Hatch and Lock

Access hatch is in good condition with a lock. The access hatch is missing a gasket. See image #23.

Recommend installing roof access hatch gasket to meet watertight roof standards.

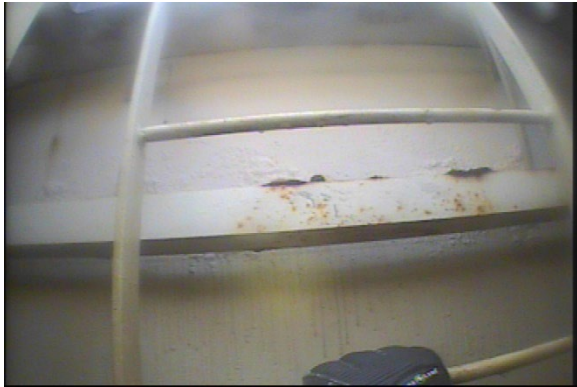
(#25) Interior Ladder Above the Water Line #1

Ladder is in fair condition with a ladder cage present. See images #24 and 29-30. **Recommend spot repair to interior ladder and removing interior ladder cage as per OSHA standards. See page 21.**

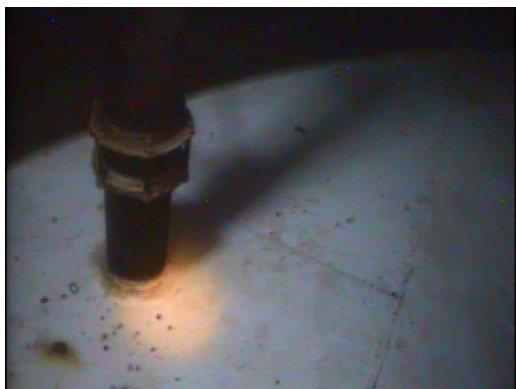
(#36) Overflow Pipe

Internal overflow is in good condition.
