City of Toledo

LINCOLN COUNTY, OREGON

Building Facilities Plan

April 2012

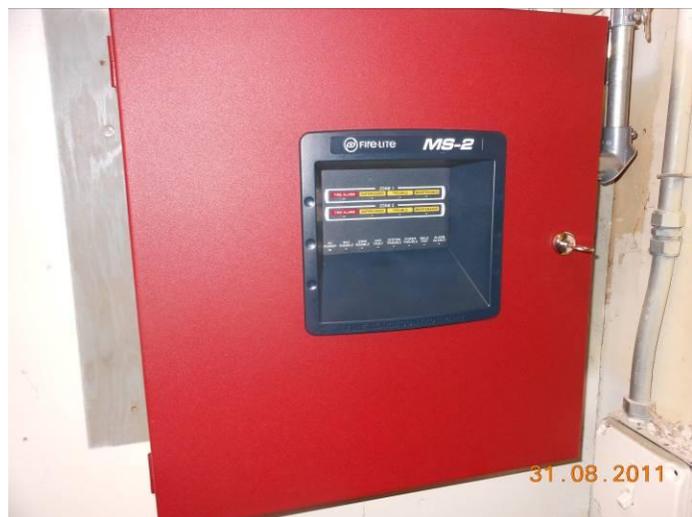
Figure 3.2.4.5 New Fire Panel

The facility is a wood-framed structure at grade with a two-story addition that has a daylight basement on the downhill side. The majority of the main level is used as a library with book shelves and tables for reading. The staff offices are located behind the counter. The lower level is divided into a meeting area on one side and a mechanical room on the other. Smoke detectors appear to be placed throughout the structure with fire alarm pull stations at the exits. The fire alarm panel has recently been replaced. The only emergency lighting is present at the main assembly door exit.

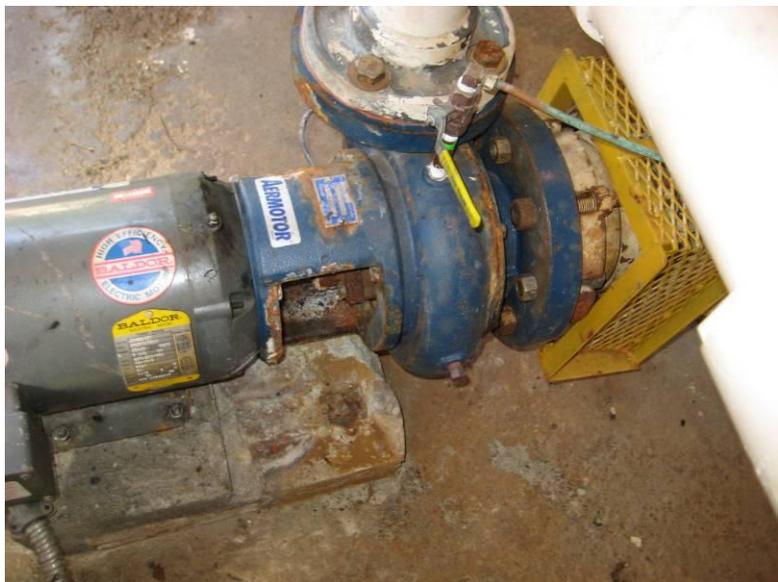
Figure 3.2.5.2 Circulation Pump

The plumbing components in the building vary from original steel pipe to more recent plastic fittings. The hot water heater is a newer variety in good condition with some visible evidence of past leaks on the copper piping. The visible interior piping is showing surface corrosion. The bathrooms have no apparent plumbing deficiencies. The piping in the filter rooms is satisfactory. The pool drain is limited as the pipe is only 4-inches in diameter. The filter media is due to be changed and the pumps are at the end of their useful life.

Pool overflow water enters a perimeter gutter and is discharged into the City storm drain system. State code mandates that the overflow water be recirculated.

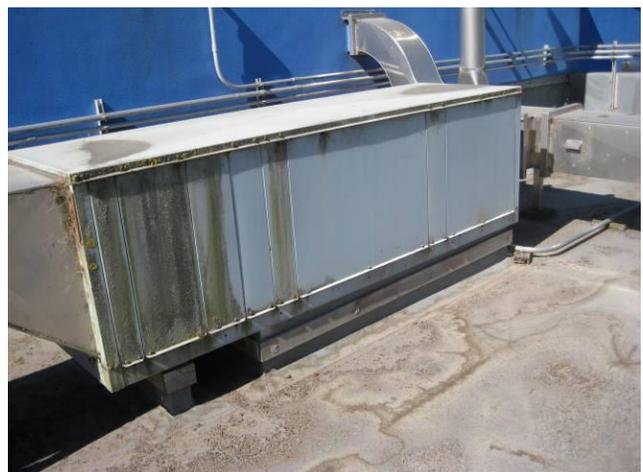
Figure 3.2.8.3 Roof HVAC Unit

The control building and lab area has a Greenheck KSU make up air ventilator installed on the roof. The unit is in good condition. The chlorine room contains a unit heater to maintain humidity and temperatures. The unit heater is not positioned properly and cannot maintain the climate setpoint. A portable unit heater is currently being used to keep the room at the proper setpoint.

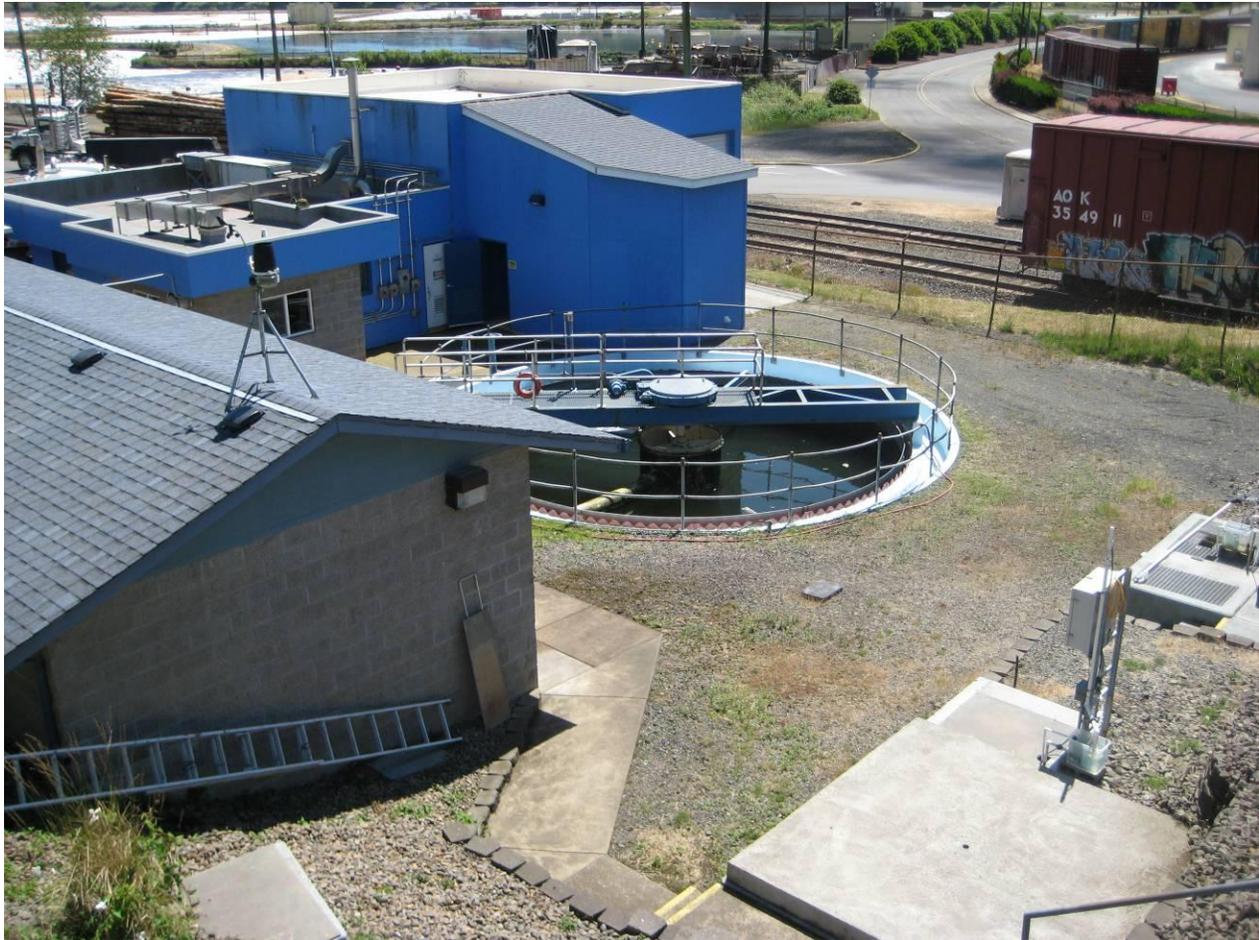
Figure 3.2.8.7 Drive Access Area

The WWTP is located at the bottom of one of Toledo's many steep slopes on Butler Bridge Road. The area is fenced off and grassy. The area will be evaluated in the Wastewater Facilities Plan. One site problem of note is the limited parking for staff or visitors.
